Steel-Window Repair Done Wright at Fallingwater

The windows at Frank Lloyd Wright's Fallingwater were in grave disrepair. A preeminent steel-window repair company was able to restore the historic windows on site.

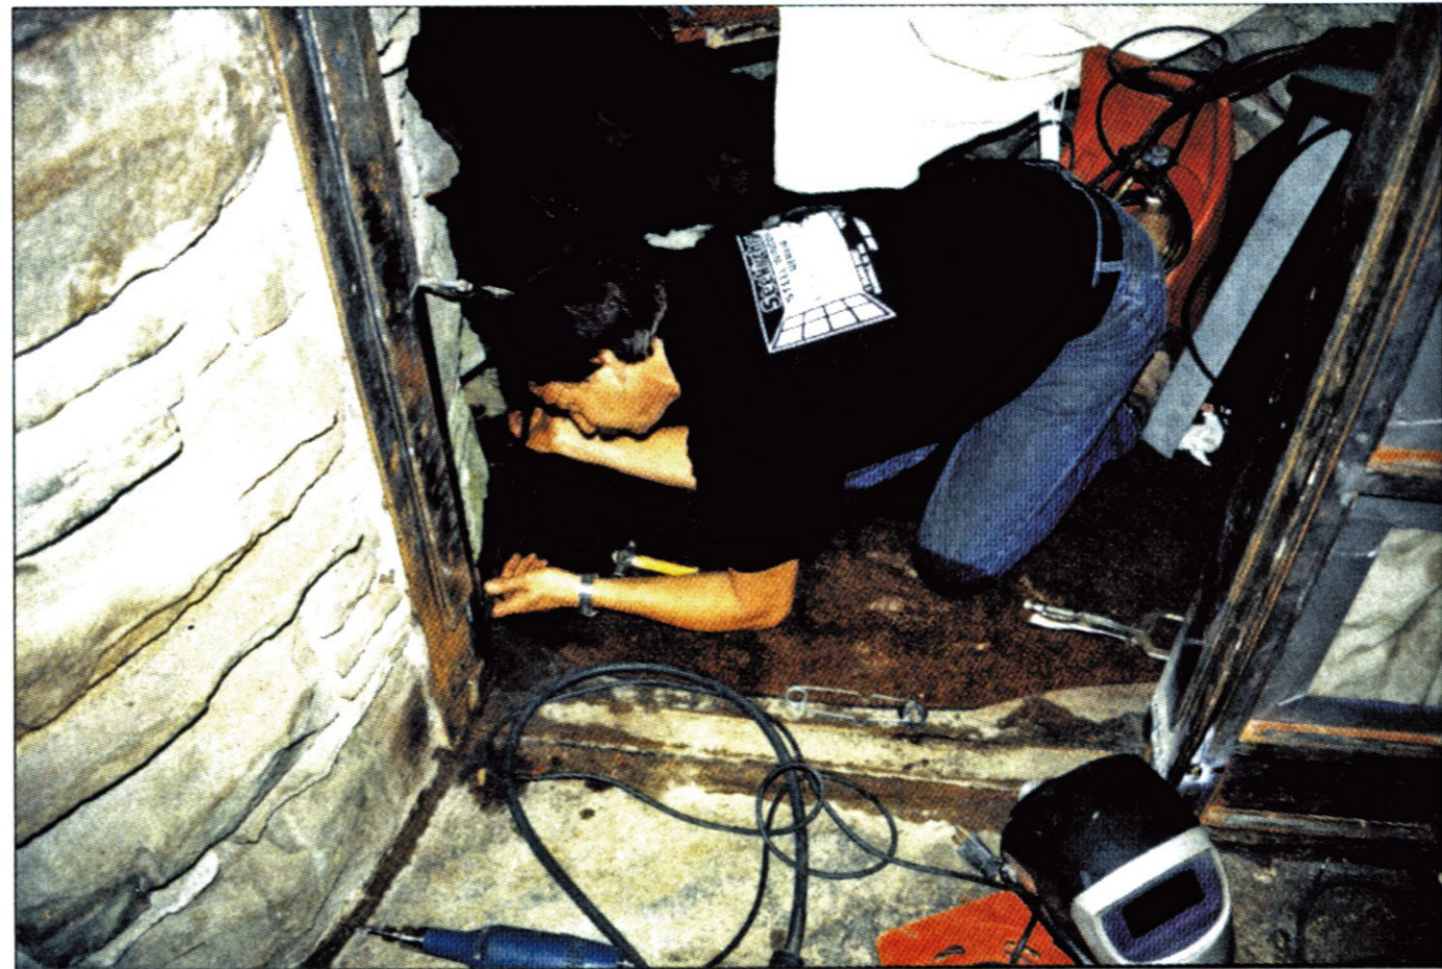
Bobby Seekircher restores a door frame, an effort that required three ten-hour days.

years earlier, to give the house better protection from ultraviolet rays.) Then Seekircher and his crew manually twisted each frame back into shape, using shims. Where metal was badly deteriorated, patches were welded on.

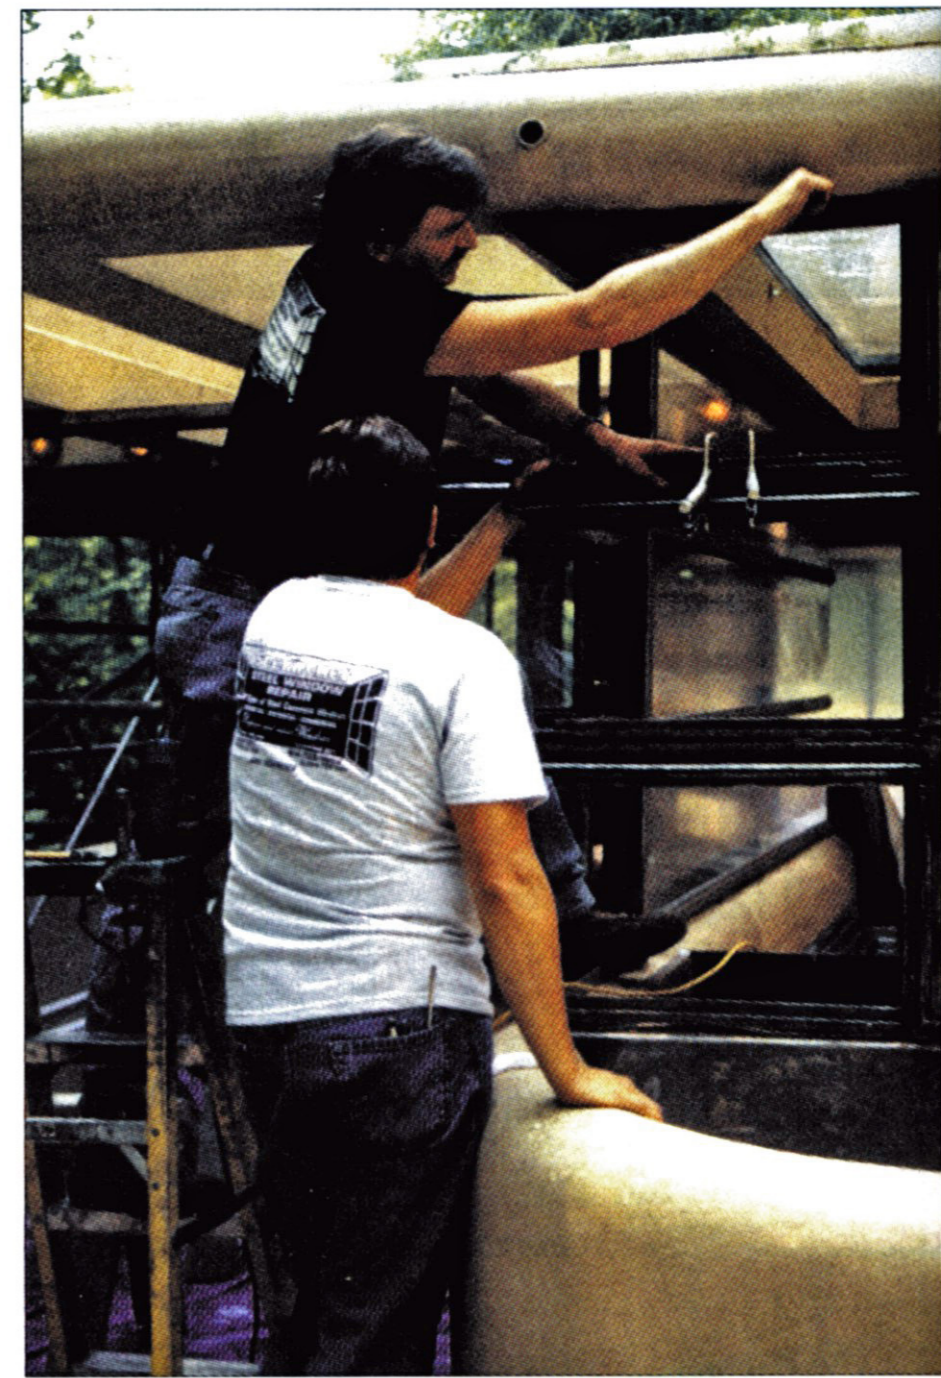
"We're almost like chiropractors, taking stress off mechanical parts," says John Seekircher, seen here with his brother, Bobby, attending to windows in the hatch area of Fallingwater.

In the past year, in consultation with Conservancy staffers, he mapped out the house, isolating repair zones from the tourists who continued to visit the site. Everywhere he worked, he engaged in the same laborious process: carefully realigning the metal, a task that took almost 3,000 man-hours and was completed in September 2001.

The first step was to open the windows, gently. Many were rusted shut. "We disconnected the hardware and got everything working and lubricated, leaving the glass in place," says Seekircher. "Taking the glass out can just create more problems." (For the record, Fallingwater's original quarter-inch plate glass had been replaced with quarter-inch laminate fifteen

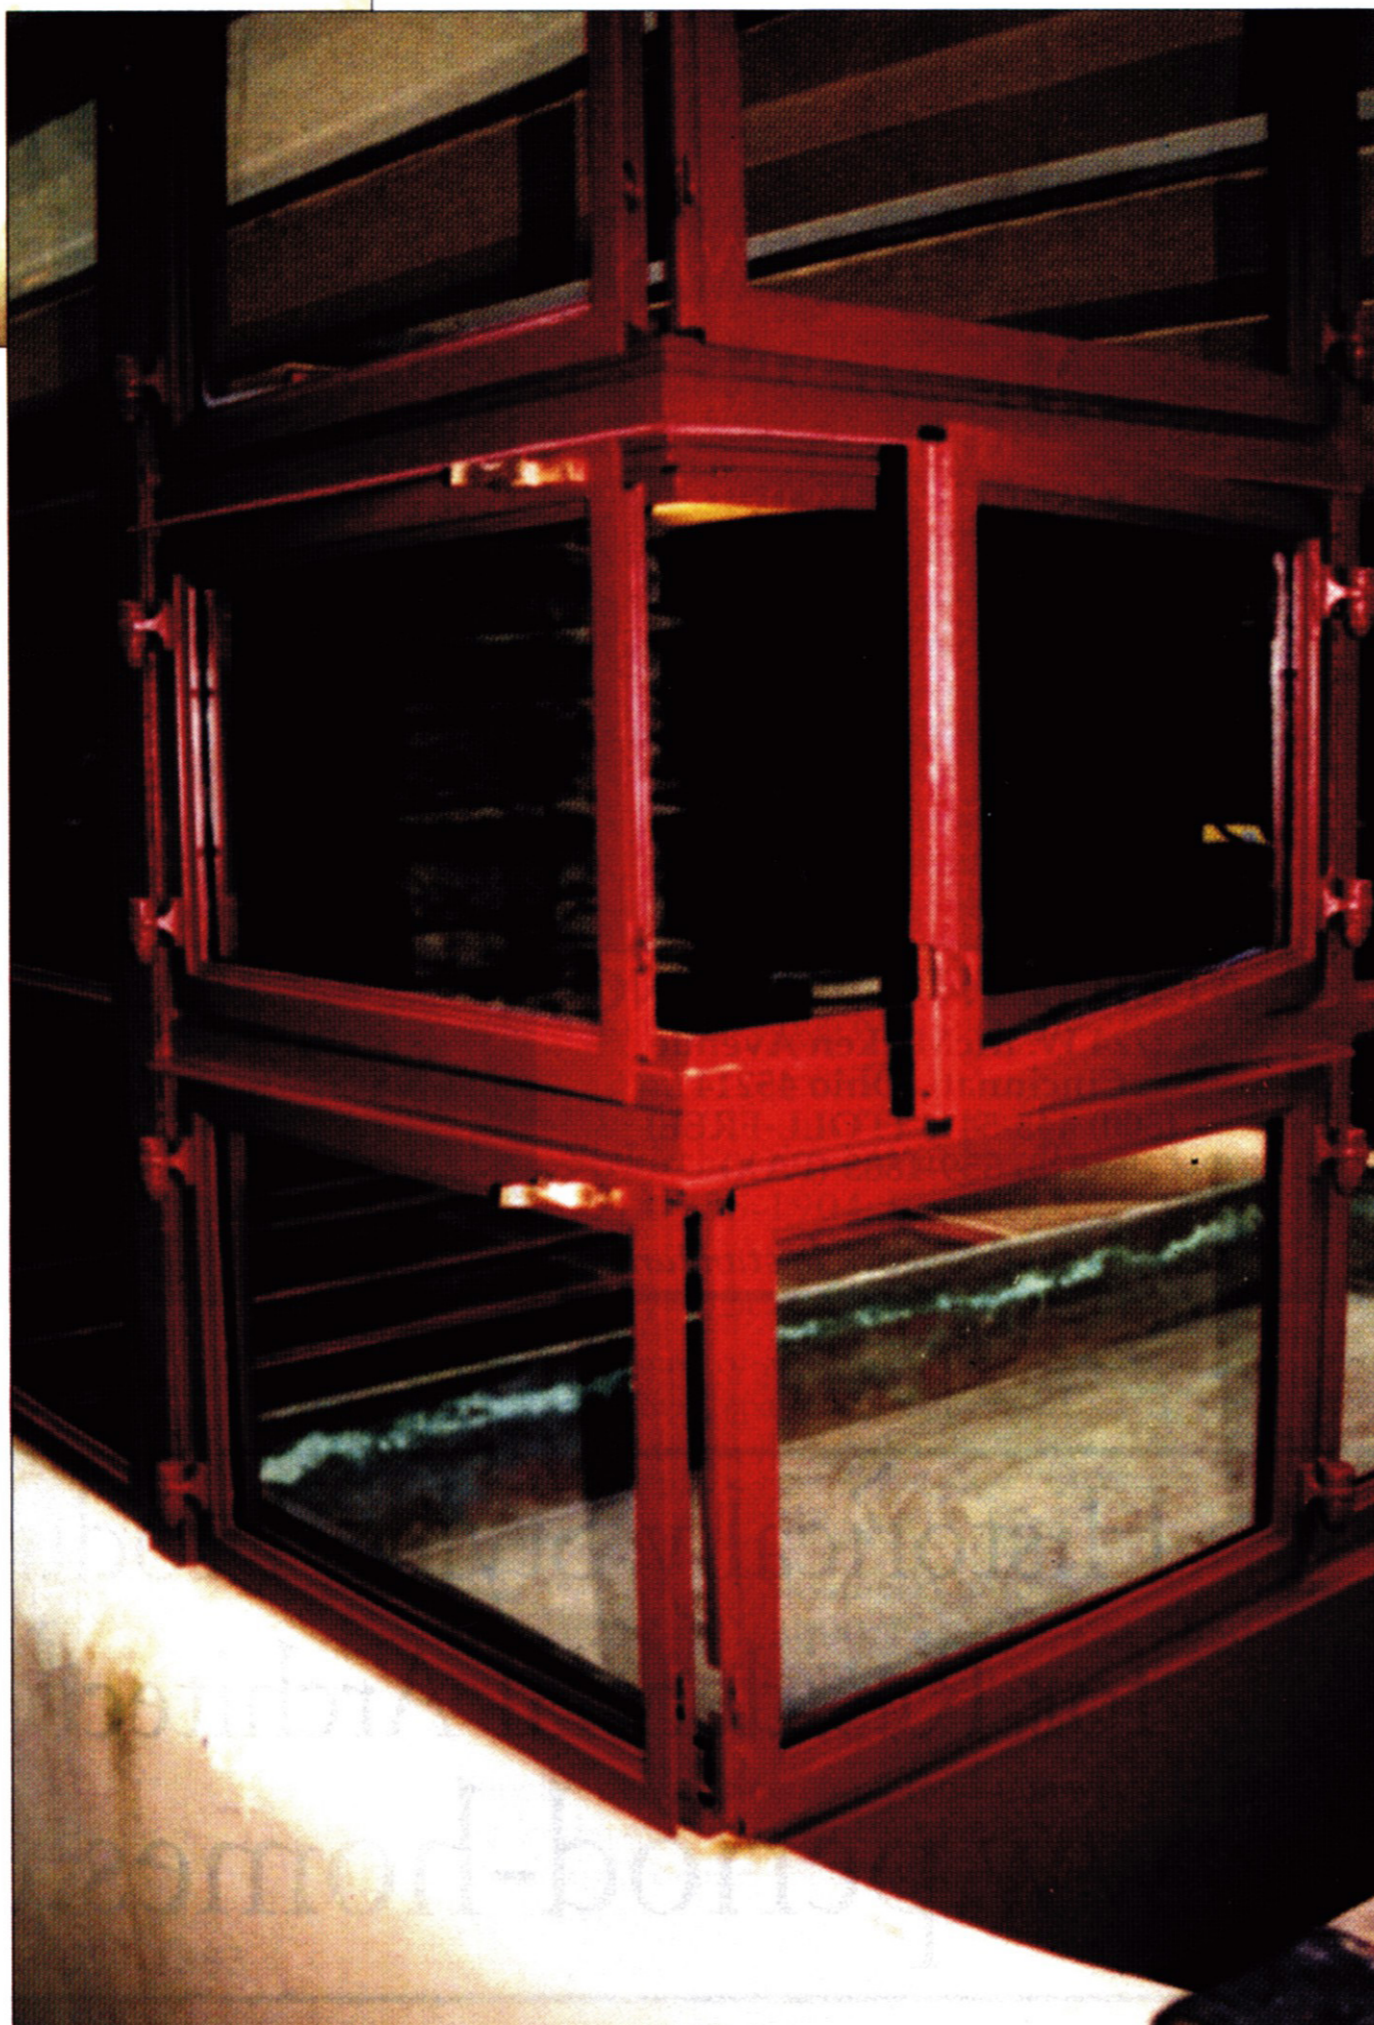
Once restored, the hatch windows open and close as designed. Note the brass hardware, which was removed for cleaning, polished to its original glow, and re-installed.

Next, painters from Patriot Restorations in Scarsdale, N.Y., and RND Painting in Hopewell Junction, N.Y. — longtime Seekircher collaborators — stripped the frames to the bare steel. The metal was treated with primer, followed by two coats of an authentic shade of Wright's "Cherokee red." Once all the frames were painted, the welded areas could not be distinguished from the original metal. To prevent future infiltration, the glazing was needle-caulked with a fine bead of sealant. Finally, the windows were washed inside and out.
