Steel Style Restored

Dryden Architecture and Design works with Seekircher Steel Window to bring post-WWI window frames and hardware back to their original form and function.

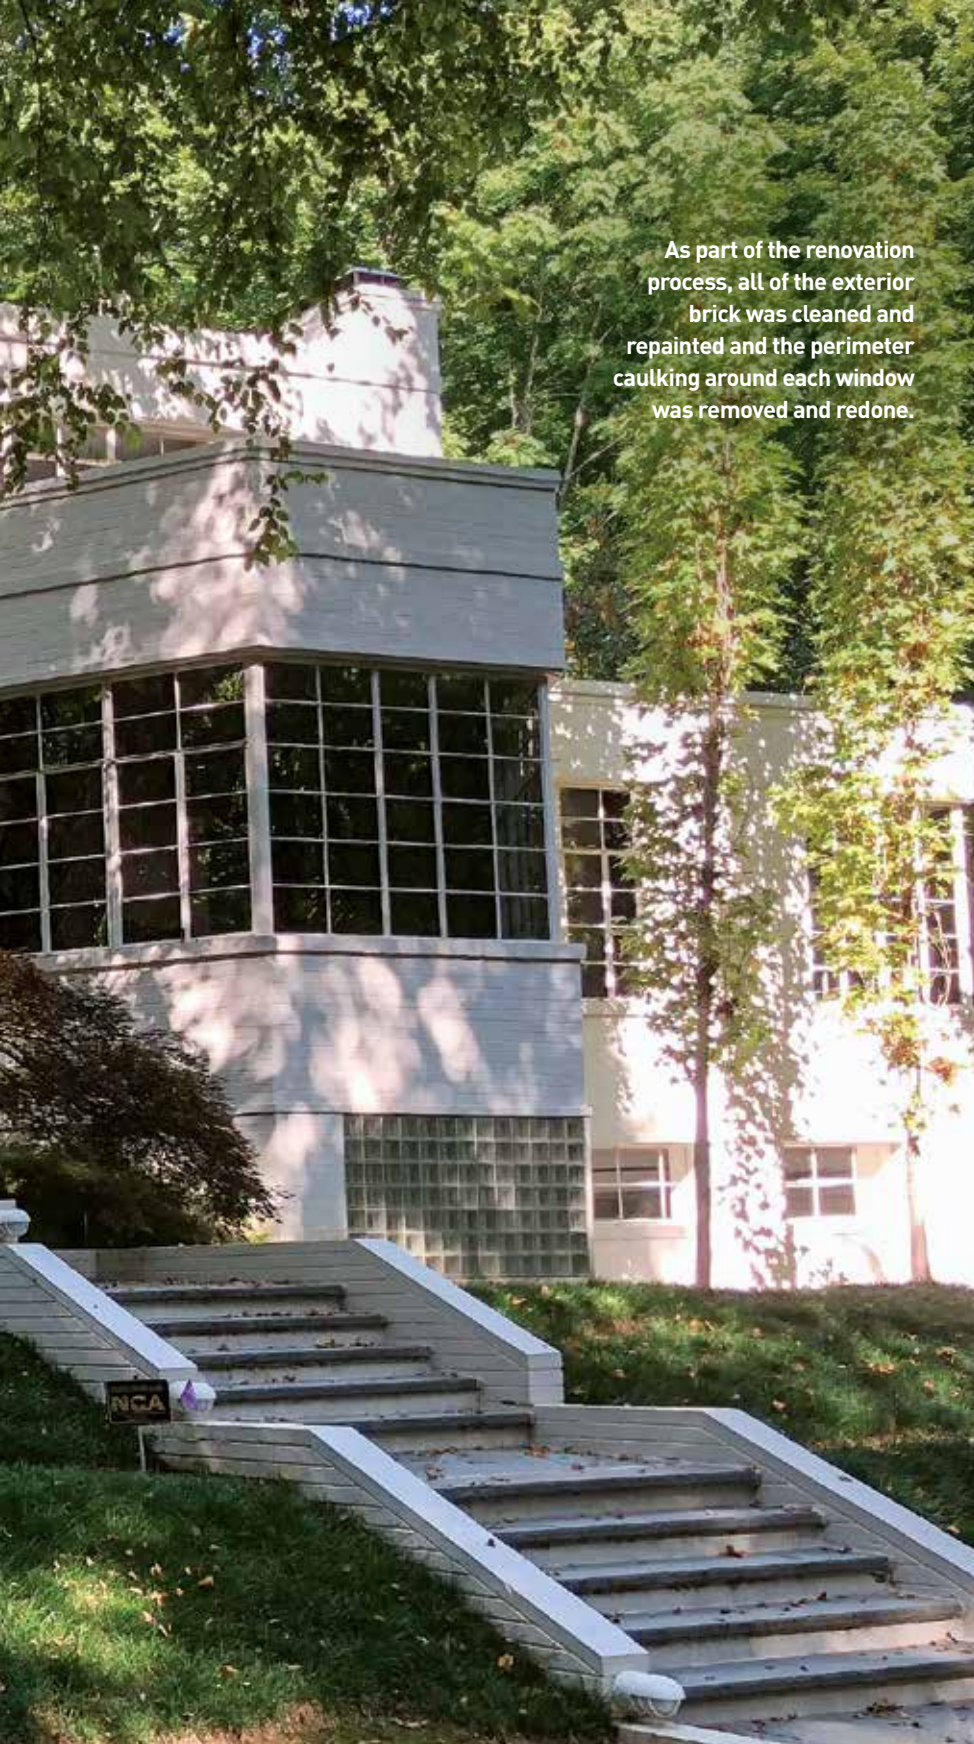
As part of the renovation process, all of the exterior brick was cleaned and repainted and the perimeter caulking around each window was removed and redone.

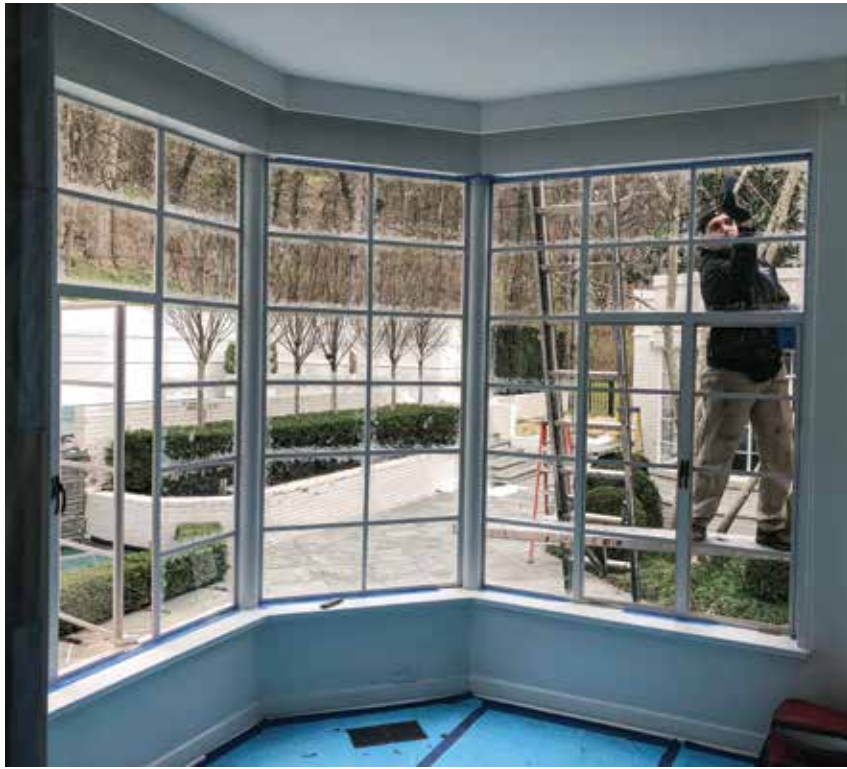
CLOCKWISE FROM LEFT After the styes are stripped and primed, the Seekircher team installs and reputs each new pane glass—over 700 individual pieces.

The Seekircher crew measured and replaced all of the existing panes, using glass from New York. “They did

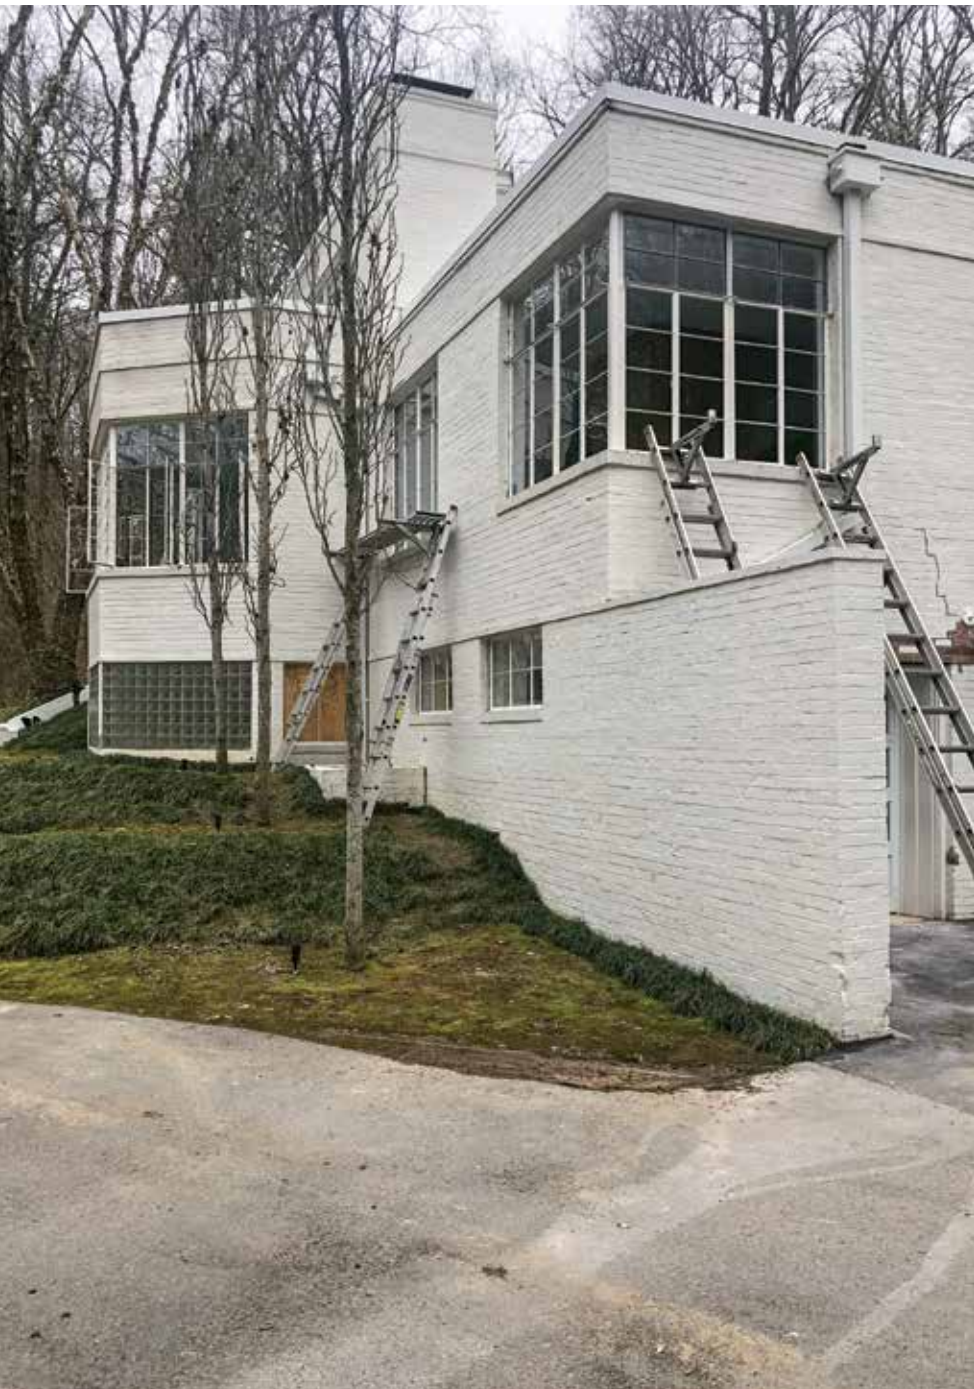
After the putty is cured, all of the exterior steel and putty receives a second coat of white primer—followed by two coats of custom mixed paint.

Going forward, the chipping of paint and subsequent steel degradation should not happen anywhere close to the degree it had prior to the restoration because, in part, of Seekircher’s painting technique. “It was a three- or four-step process with specially formulated paint and an application designed for steel windows,” Sinz notes. “The current finish should last and be more resilient for decades to come.”

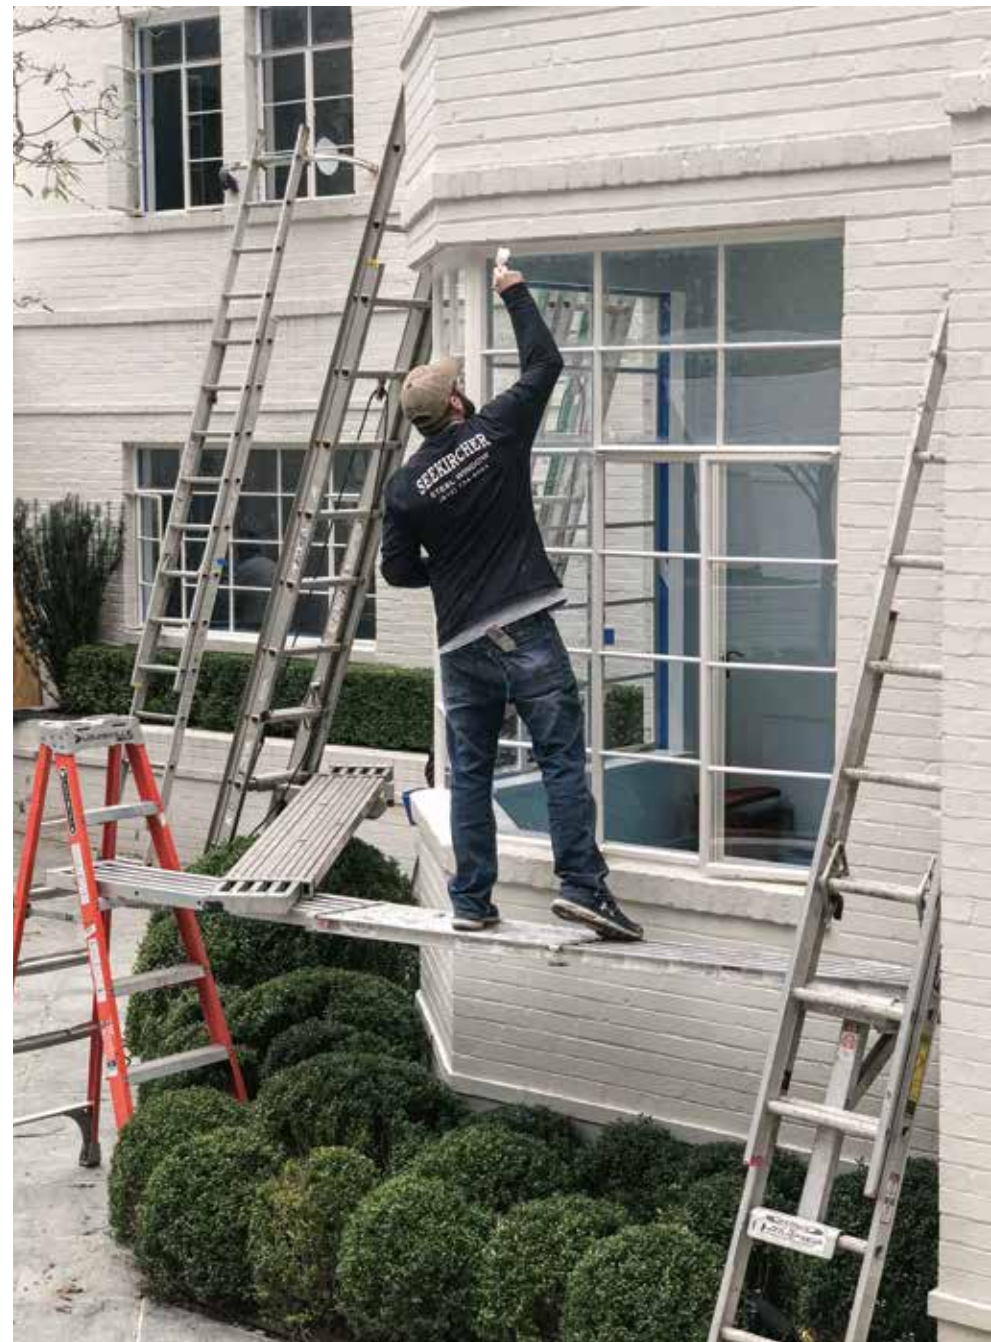
After the window sashes are re-hung on the frames, the windows are ready for their final cleaning and coat of paint.
