NATIONAL
TRUST
FOR
HISTORIC
PRESERVATION®

Repair or Replace Old Windows

A Visual Look at the Impacts

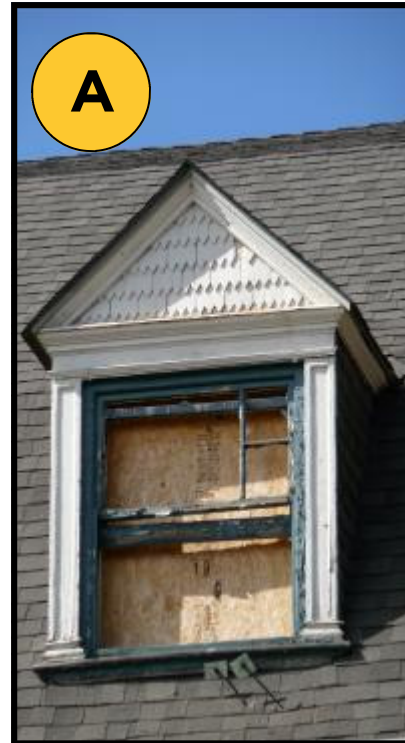
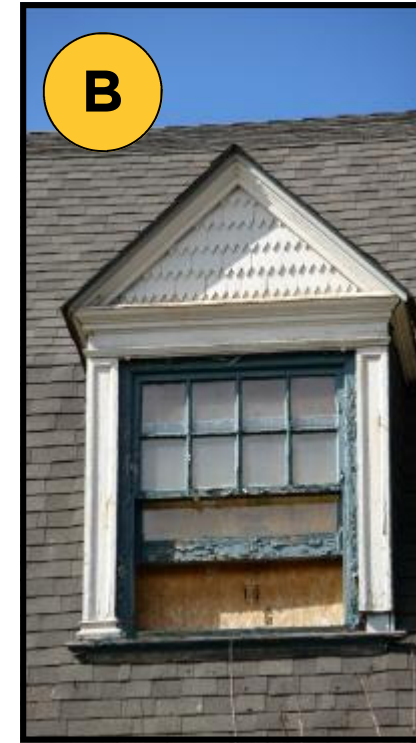
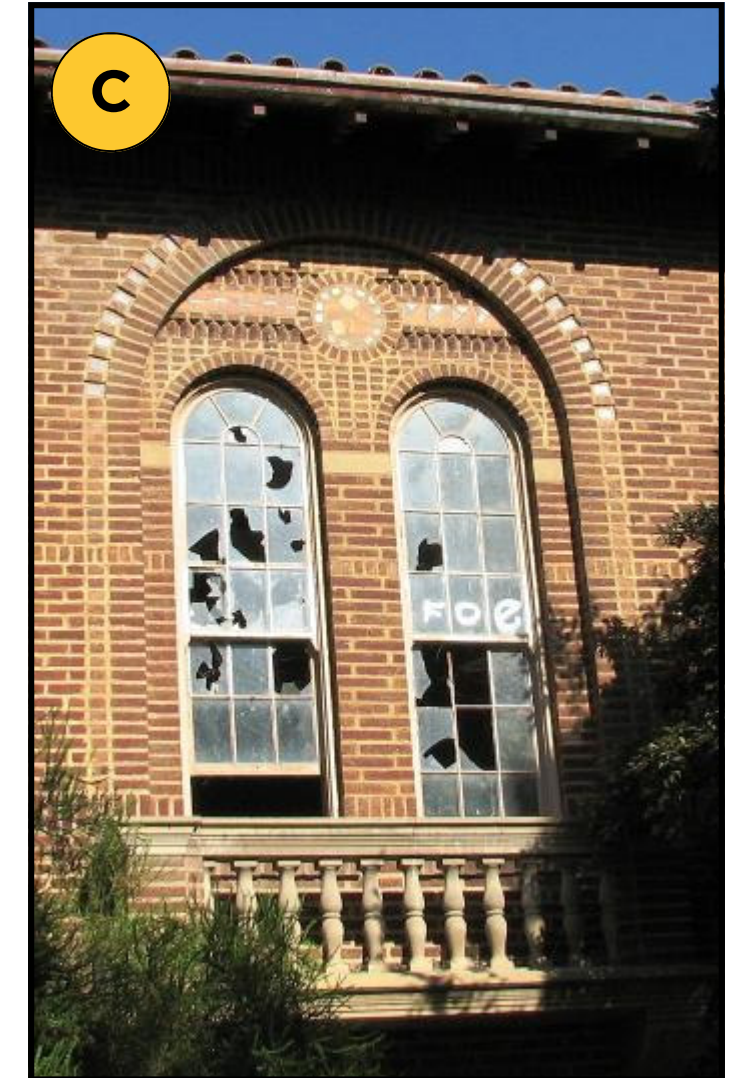
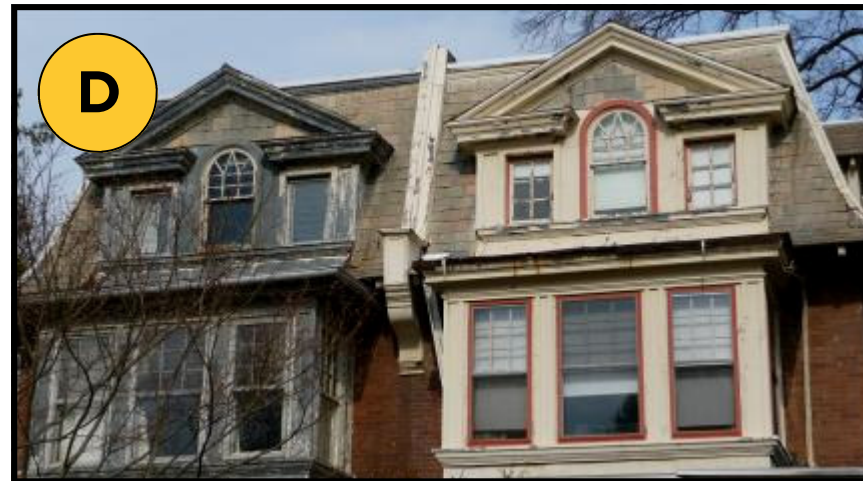
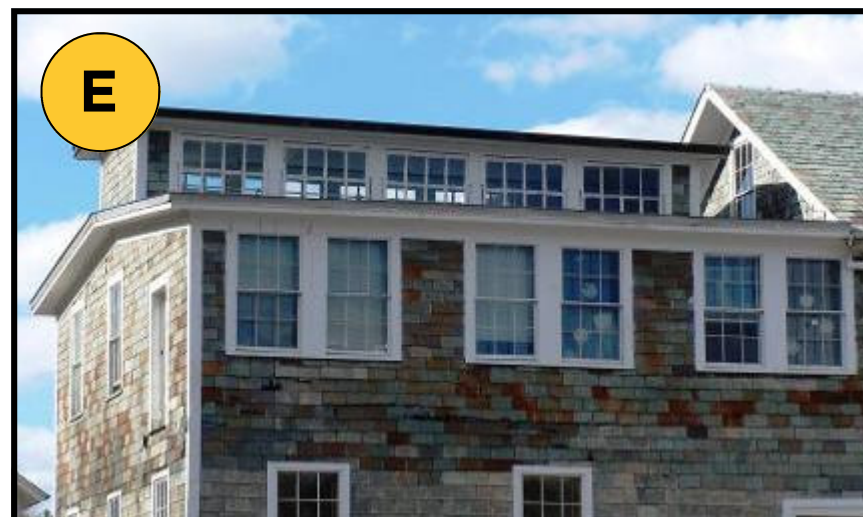
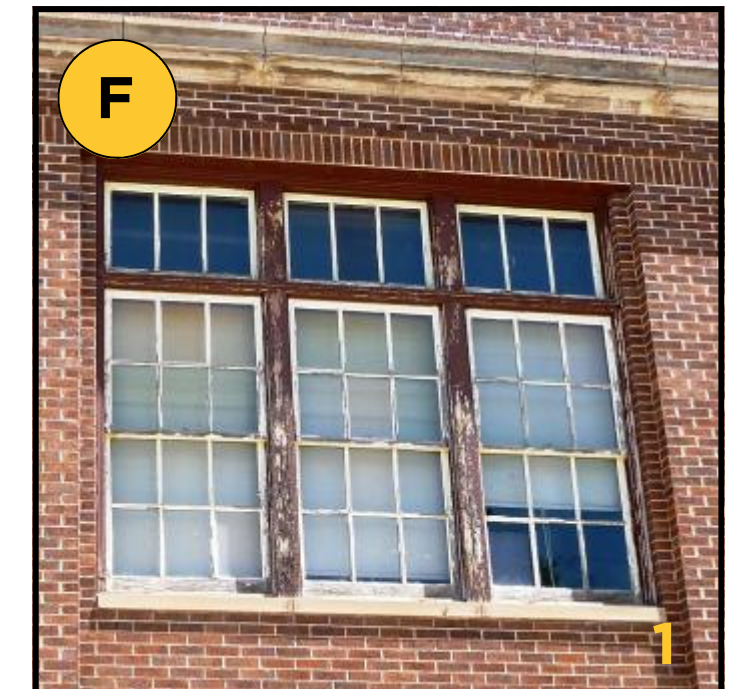
- A, B Two eight-over-eight double-hung sash dormer windows. Both are in disrepair; window A will need to be rebuilt or replaced to match window B.
- C Broken glass on these architecturally distinctive windows can be easily replaced and windows repaired.
- D A coat of paint and routine and preventive maintenance can restore windows to their original appearance.
- E Unique roof monitor with well-maintained and character defining six-over-six double-hung sash windows.
- F Group of six-over-six double-hung sash windows with transoms, only needing paint.

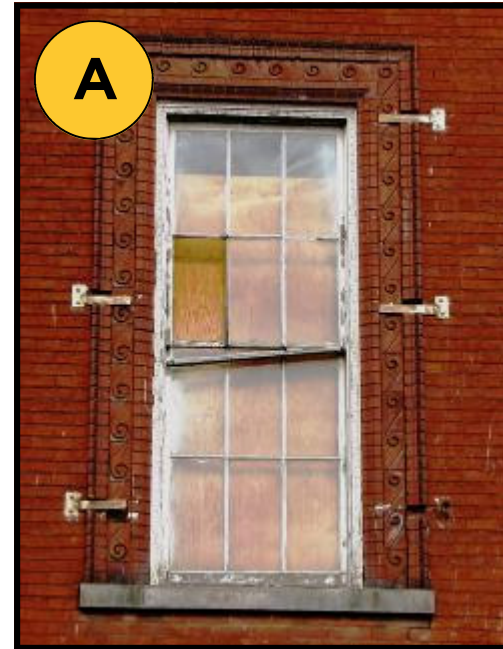
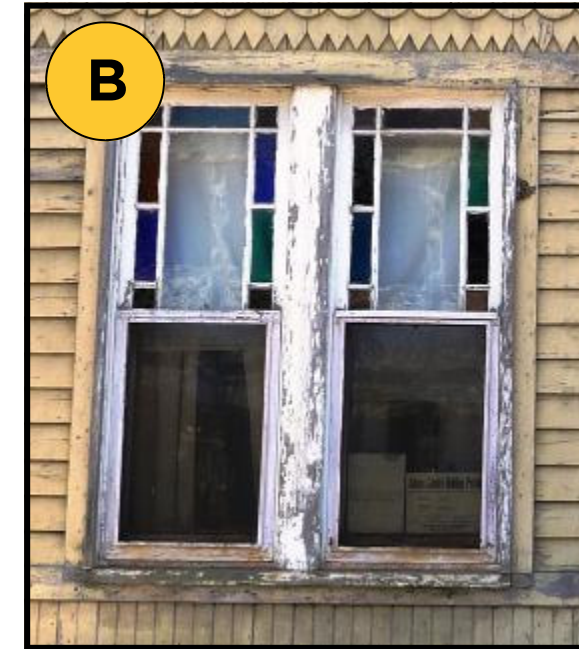
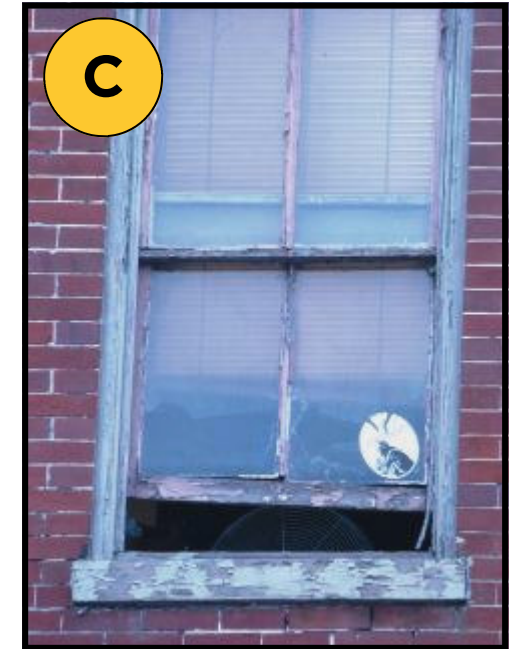
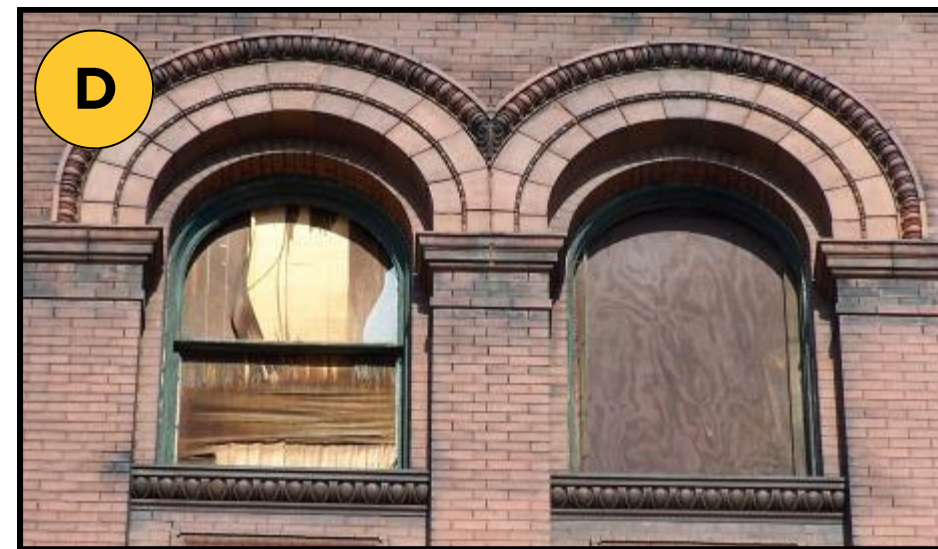
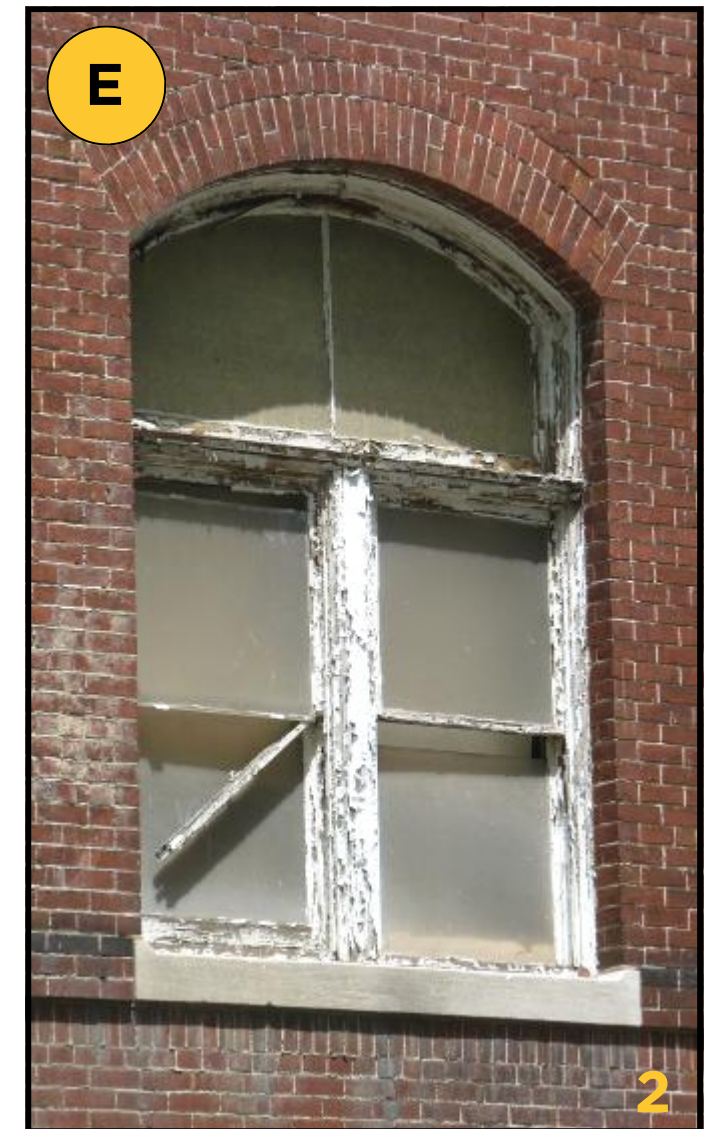
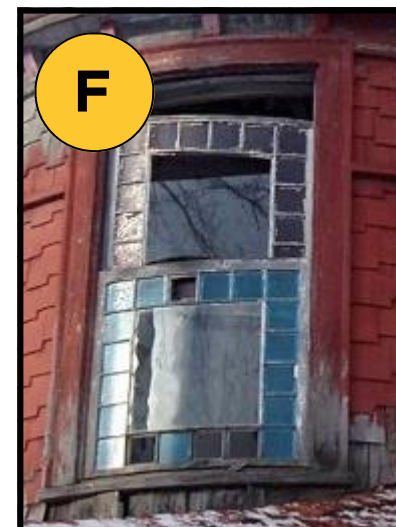
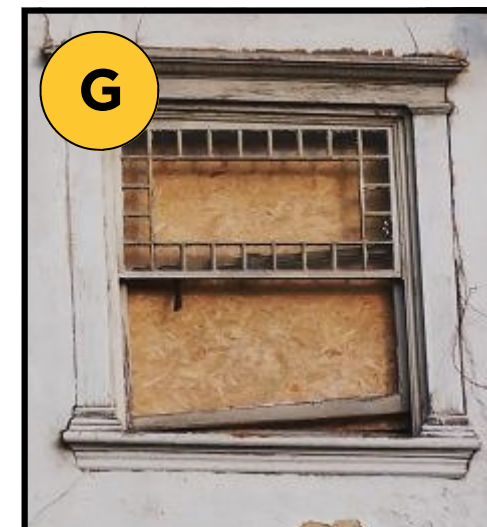
- A Six-over-six double-hung sash with loose meeting rail, missing glass — can be repaired.
- B Queen Anne windows needing paint, re-glazing — can be repaired.
- C Two-over-two double-hung sash with loose bottom rail, needing paint, re-glazing — can be repaired.
- D Arched double-hung sash windows missing glass and frames — replacement likely.
- E One-over-one double-hung sash windows and fixed transoms with detached meeting rail, needing paint and re-glazing — can be repaired.
- F Queen Anne window in poor condition, detached from frame and missing glass — borderline, requiring extensive repairs.
- G Queen Anne window missing glass and subject to structural settling of the building — borderline, requiring extensive repairs.

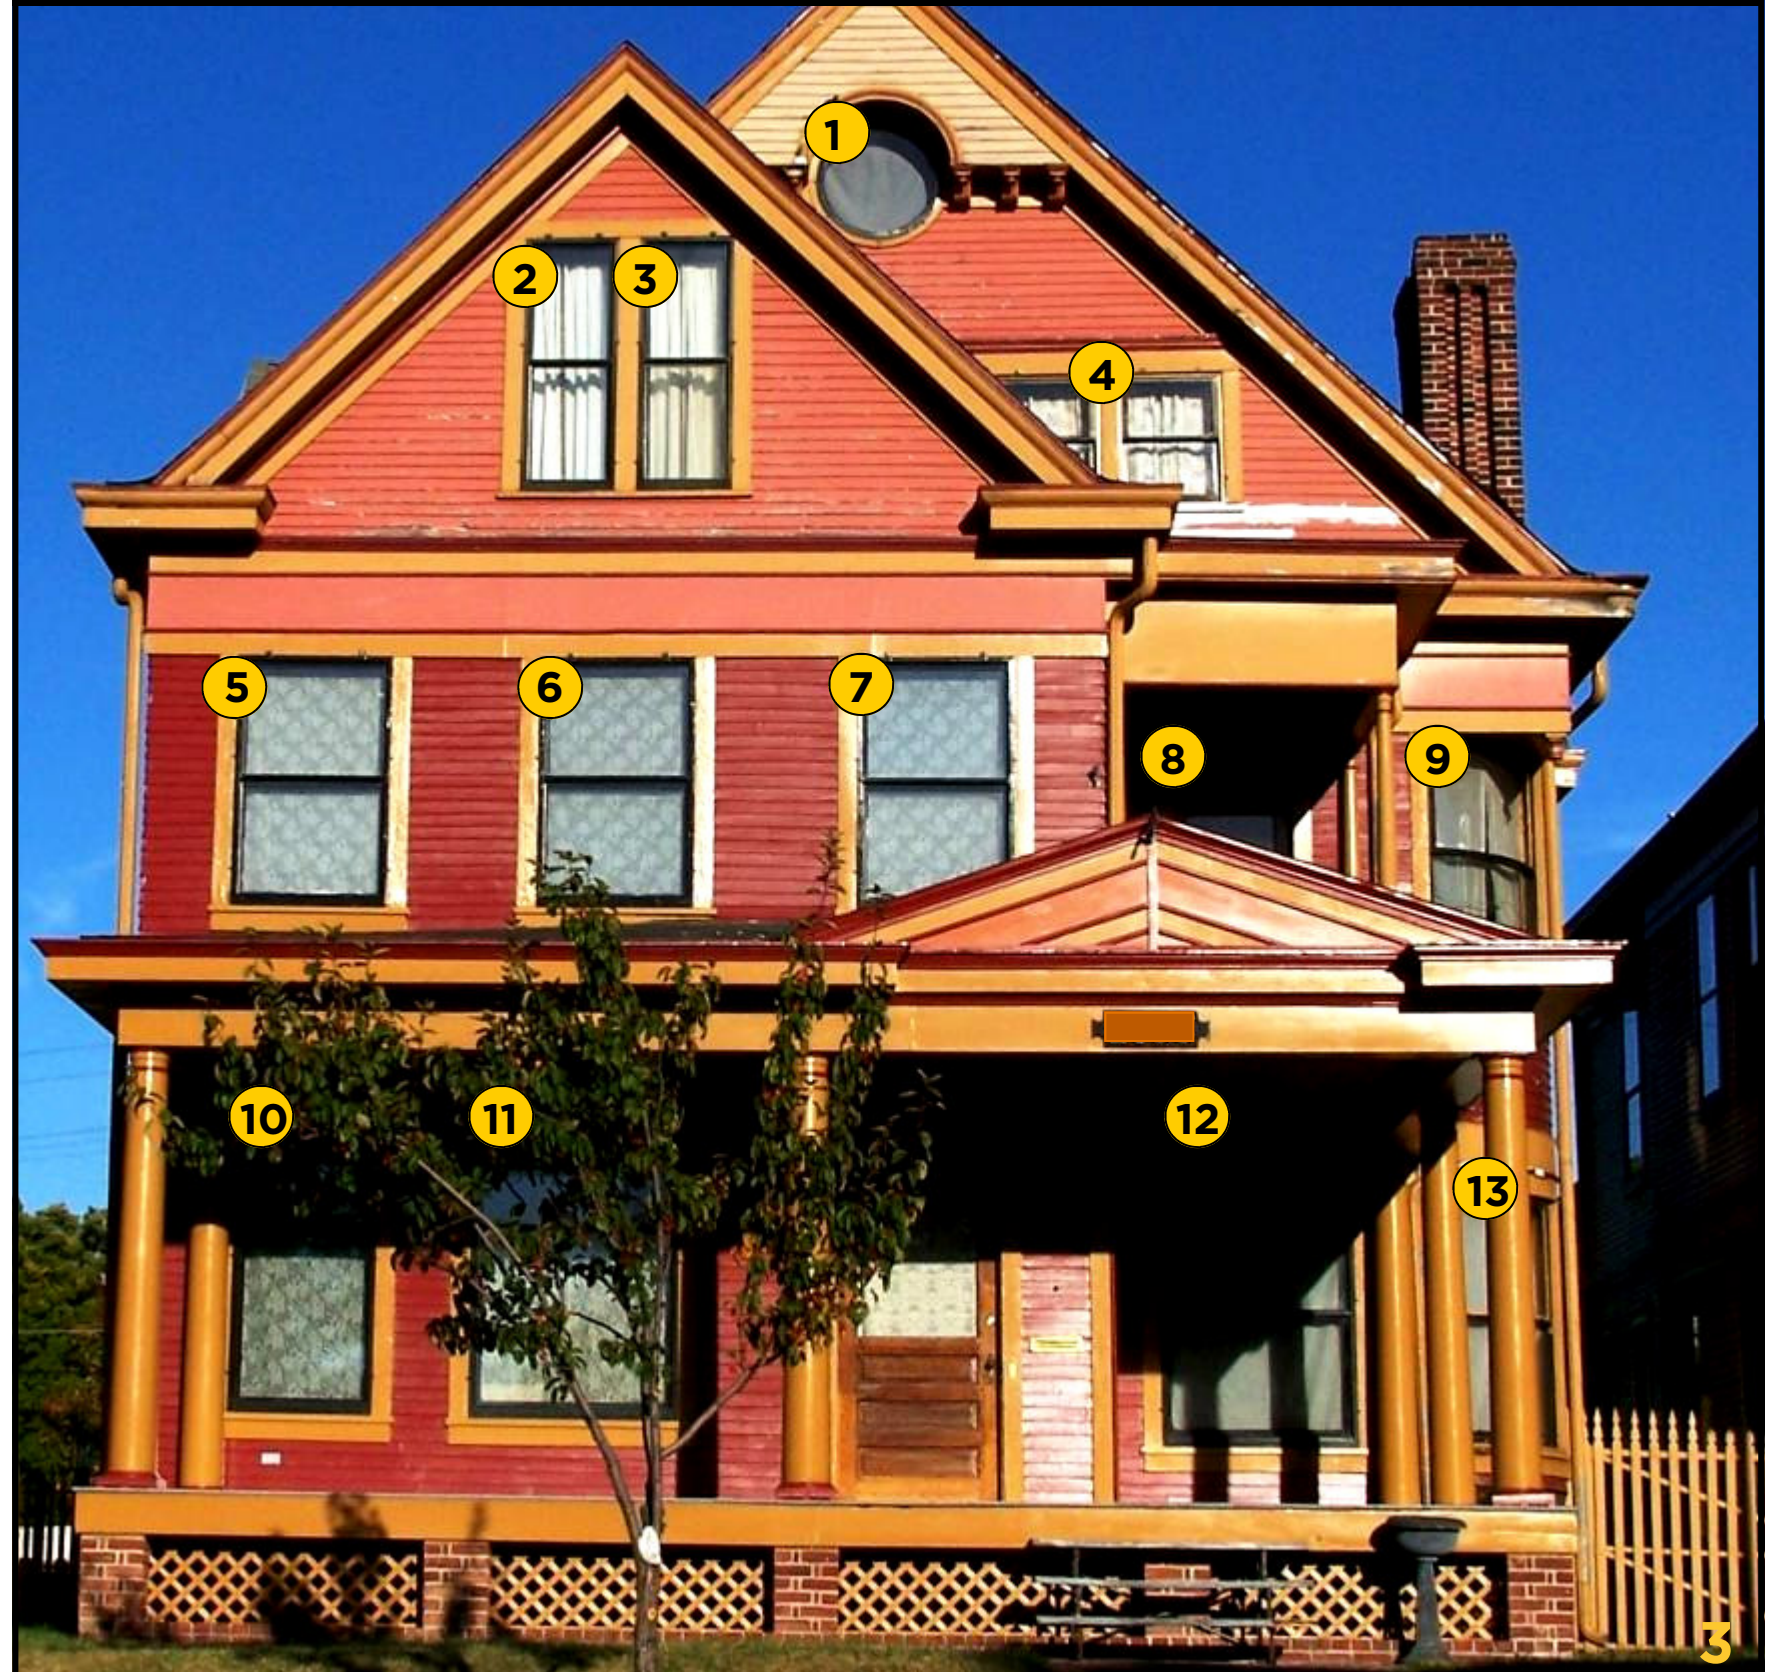
1890s Queen Anne style house
Original one-over-one double-hung sash windows with storm windows

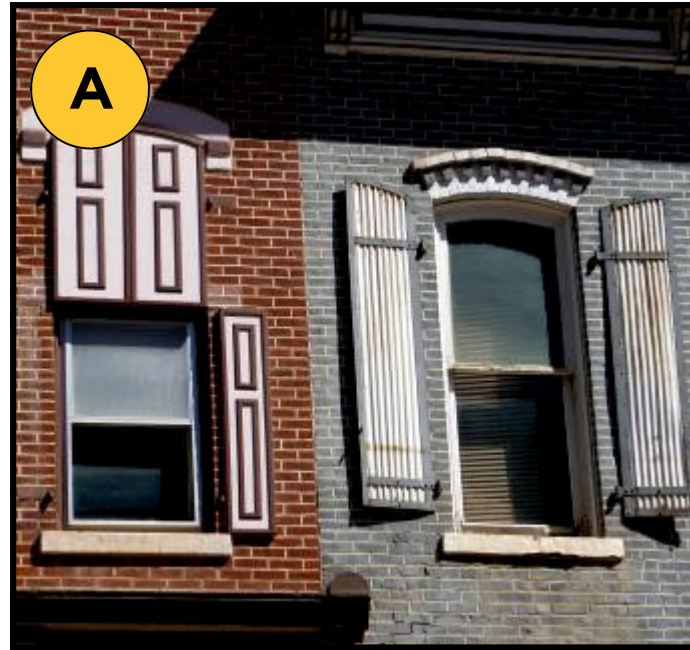
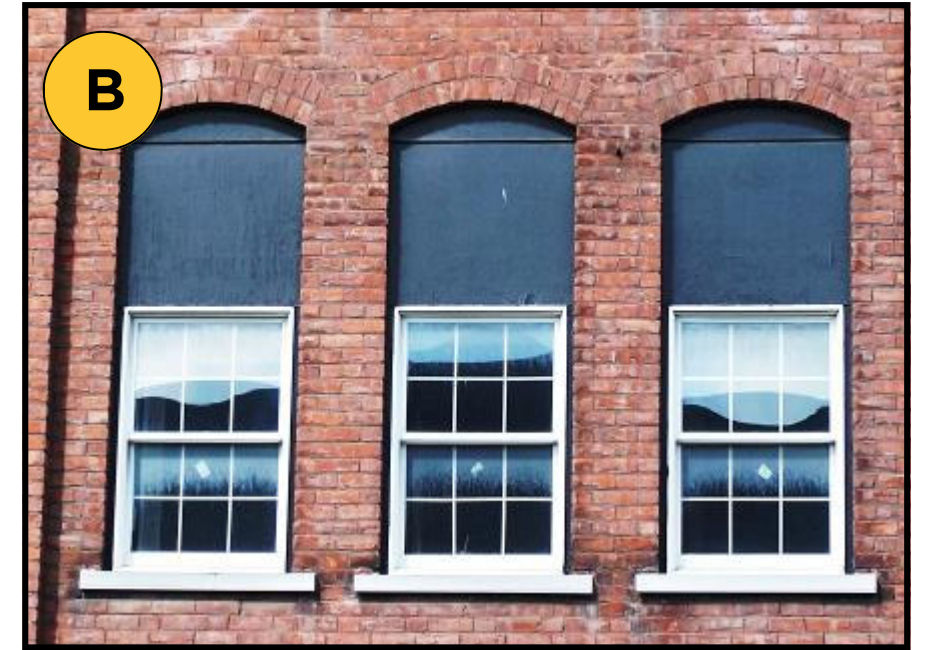
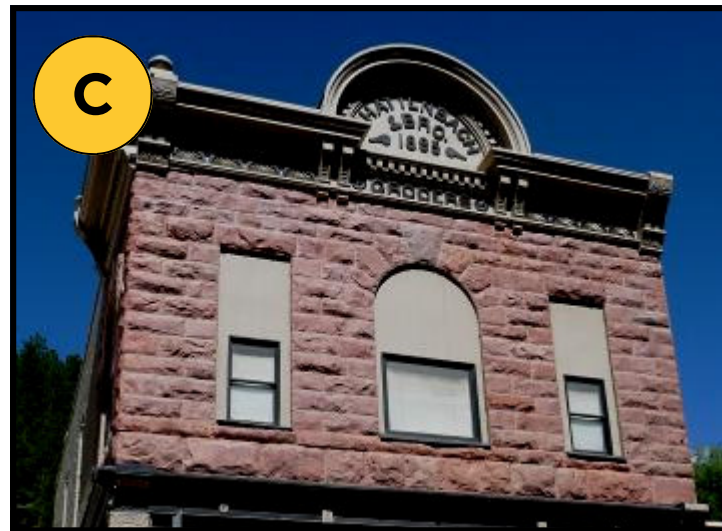
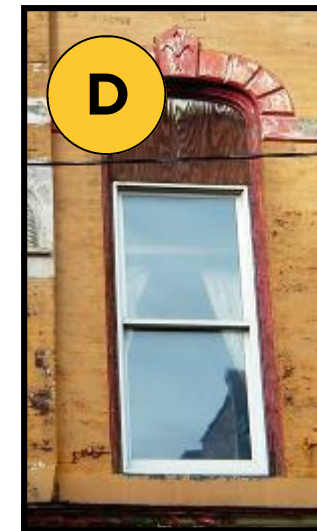
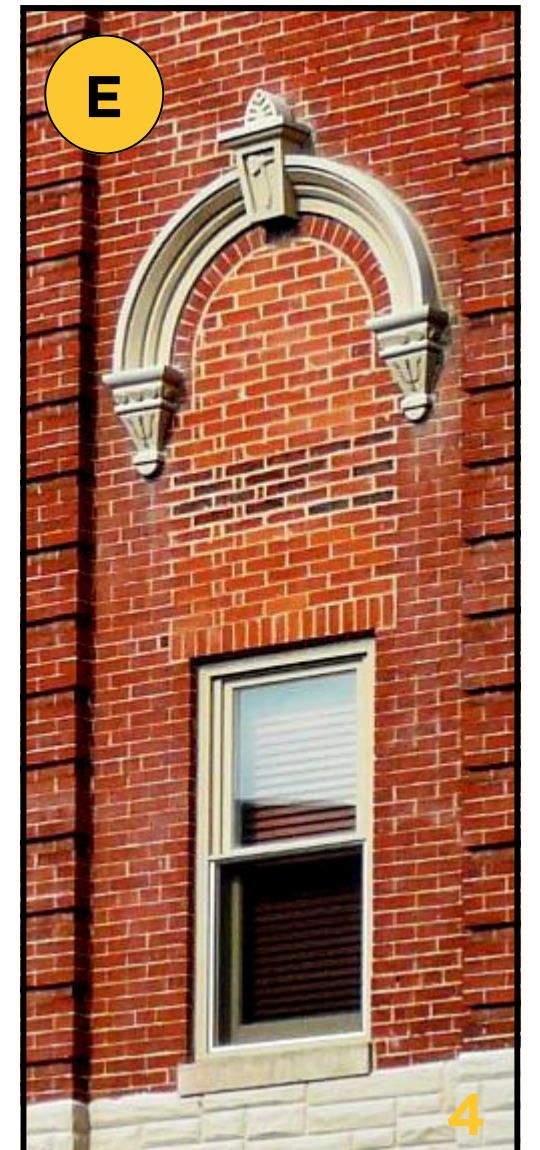
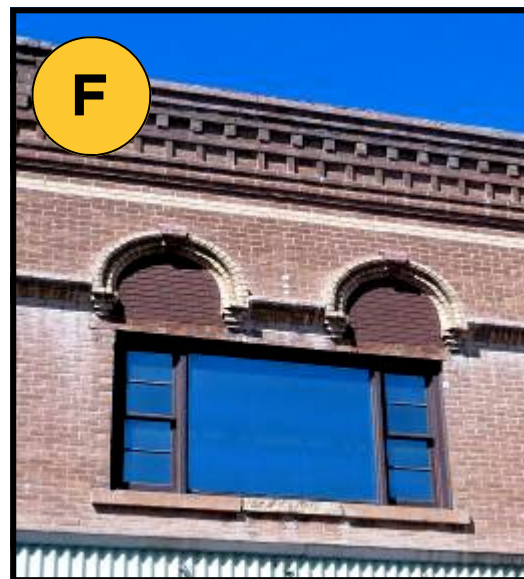
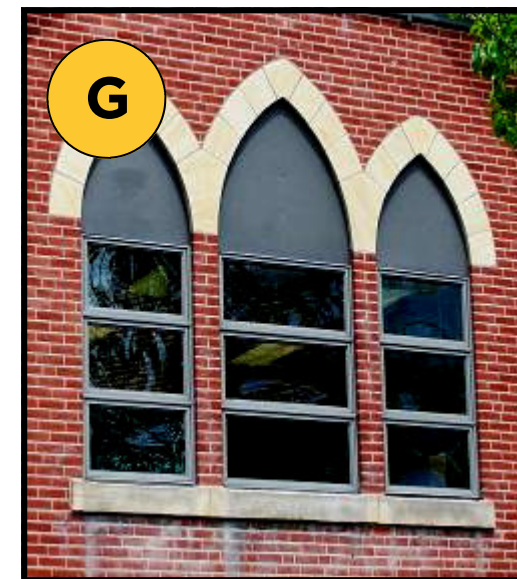
- A Italianate style row houses, side by side. Building to the right retains original arched one-over-one double-hung sash windows. Building to the left has smaller replacement windows and in-fill panels installed in the original opening.

- B Industrial building converted for housing with reduced windows and in-fill openings.
- C Main Street commercial building with upper floor windows removed, openings reduced down and much smaller replacement windows that do not match.

- D A stock, smaller window unit was used to replace a larger double-hung sash window.
- E Brick was used to in-fill the original opening of the round-arched window.

- F Two round arched windows were removed and replaced by one larger picture window, completely different in design and period to the historic Main Street building.

- G Three vertically-oriented Gothic style windows were reduced and replaced by horizontally-oriented hopper type windows.

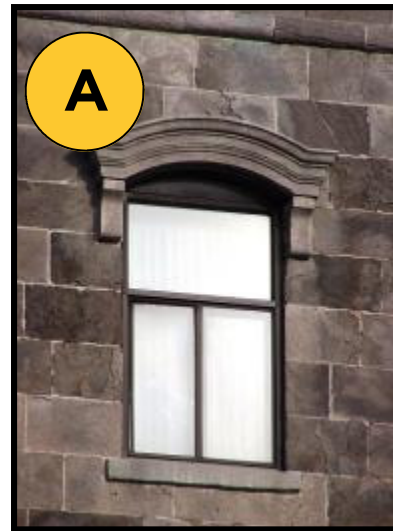
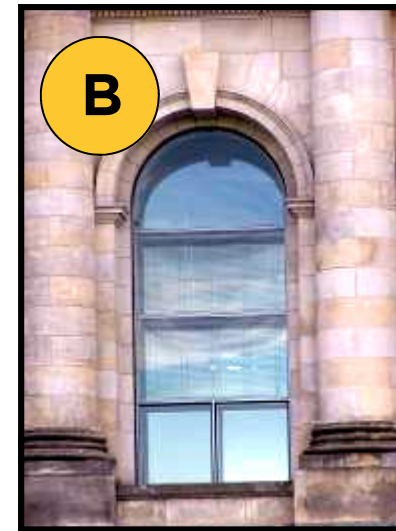
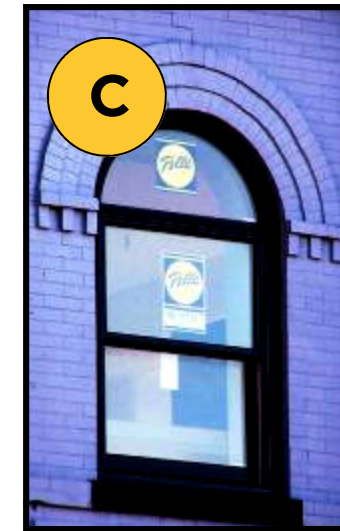
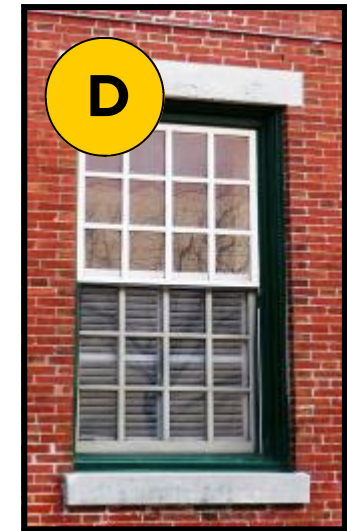
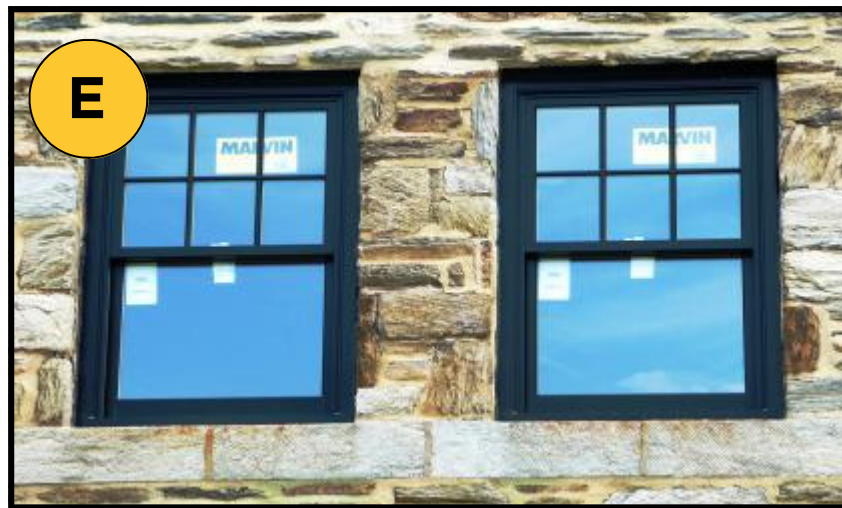
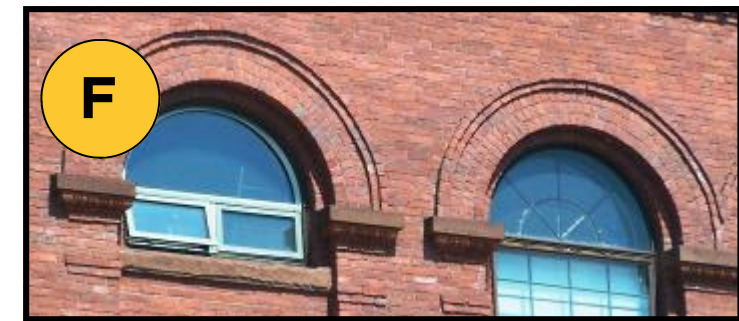
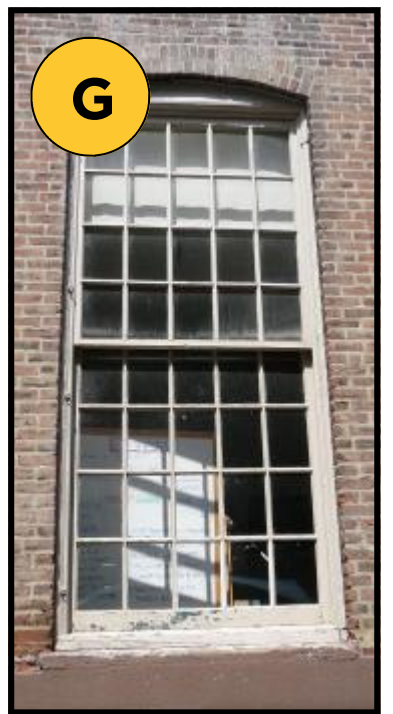
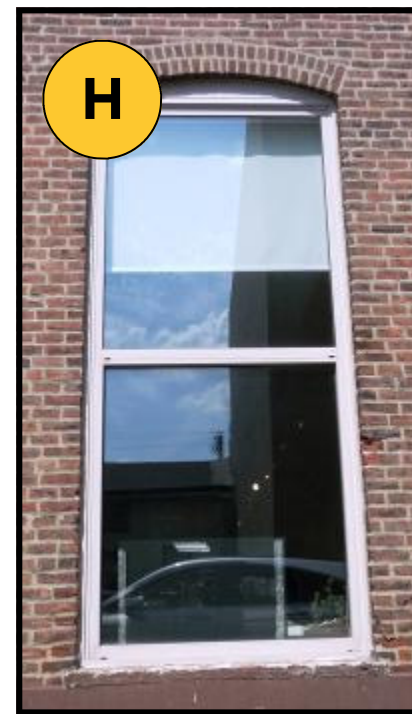
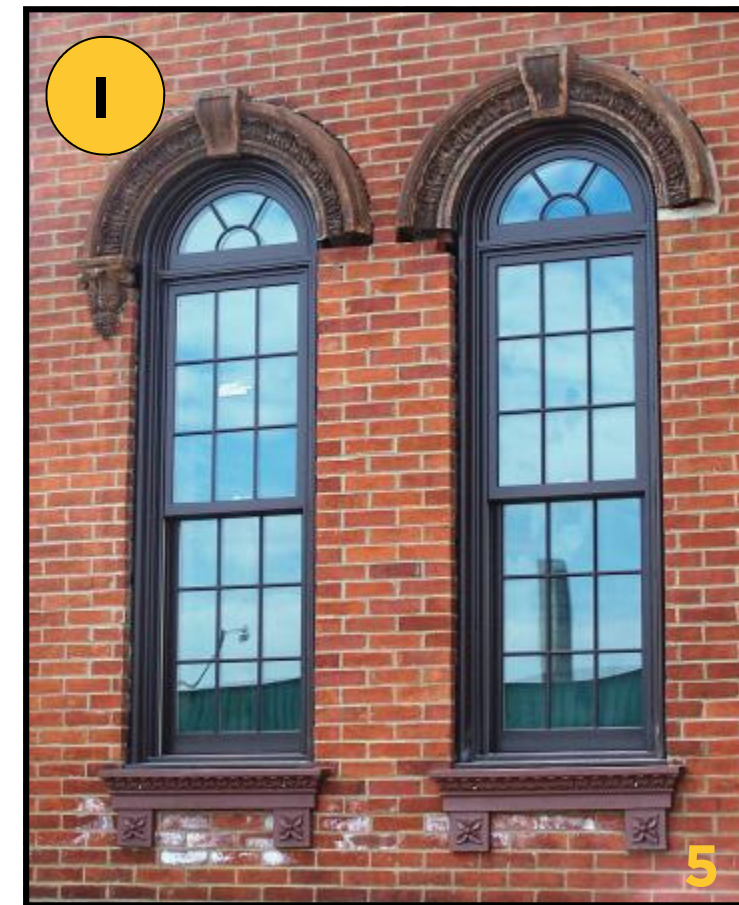
- A Replacing an original double-hung sash window with a casement and fixed transom dramatically changes the look and architectural character of this historic building.

- B Modern interpretation of an arched window alters the pattern and overall design on this monumental civic building. If original windows are no longer intact, this approach may be acceptable as windows clearly reflect their own era.

- C Replacing a round arched double-hung sash window is a one-over-one double-hung sash with fixed transom. This illustrates using stock windows to fit an opening that often requires a custom or more costly replacement window.

- D The thickness of muntins as well as their profile can make a difference. This window is not a true divided-light design, instead featuring applied, flat muntins.

- E New windows will often require 'building out' and enlarging the casing and surround to accommodate a stock replacement unit, effectively reducing the size of the window in comparison to the originals.

- F The introduction of a hopper window completely alters the look of this window.
- G, H Window G features the original twenty-over-twenty double-hung sash window. The replacement, window H, is a fixed one-over-one unit. The design, profile and depth are altered in the process.

- I New windows attempt to replicate originals, though the casing and surround is wider and the fixed fanlight does not match originals.

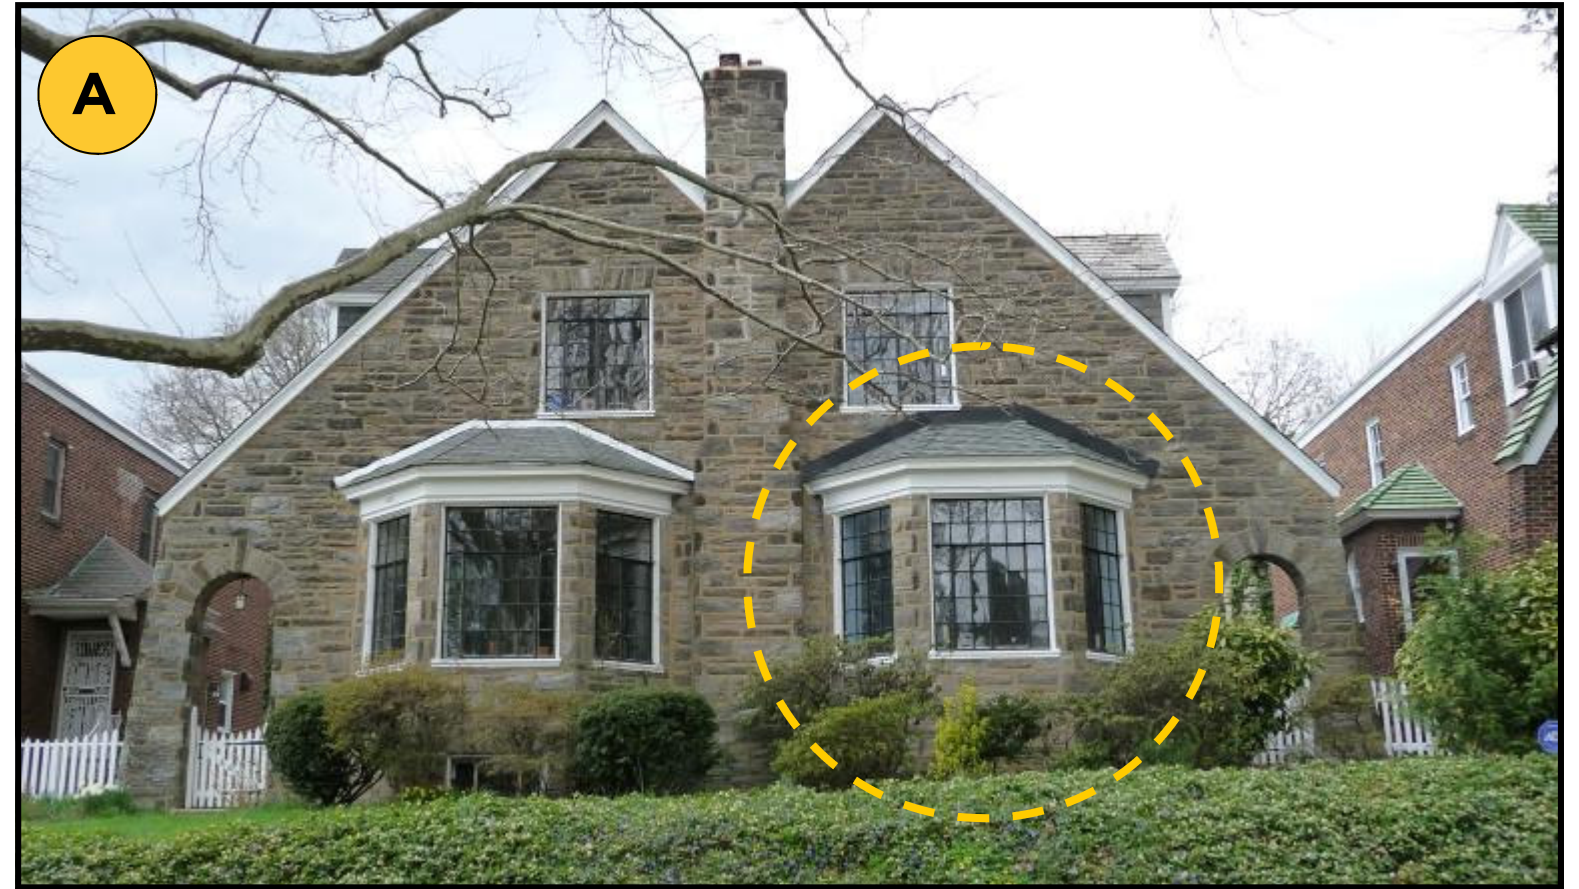
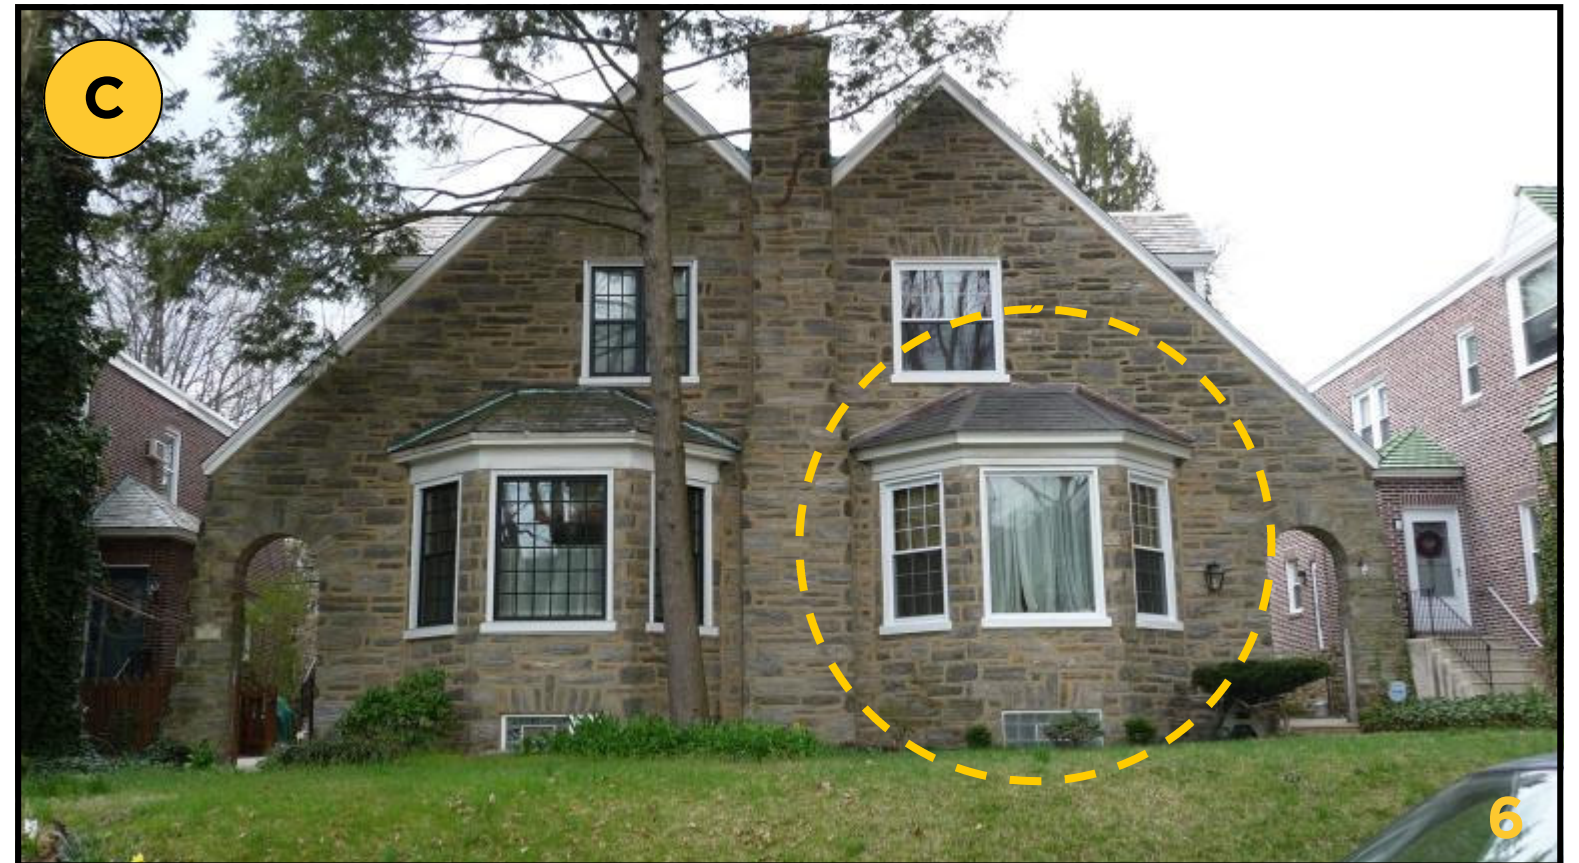
- A, B Both sides of this duplex feature original rolled steel casement windows with interior storm window inserts.
- C, D Both sides of this duplex have replacement windows. The one to the left more closely mimics the lines and details of the original steel casements, though the new windows are a mixture of fixed and double-hung sash units and the proportions are not an exact match. The unit to the right also features fixed and double-hung sash replacement windows. In this case, the result is less successful with white vinyl casing and a central picture window missing any muntin pattern.

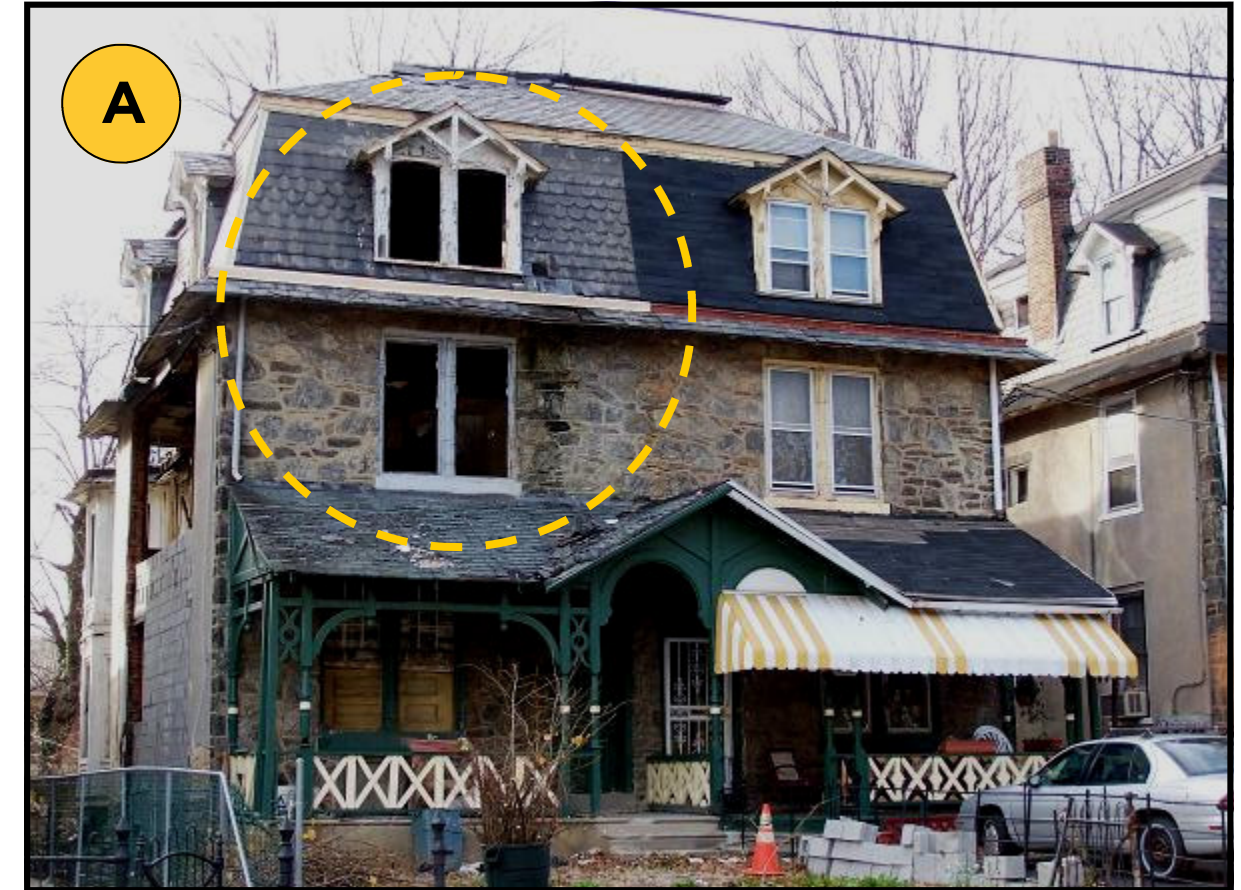
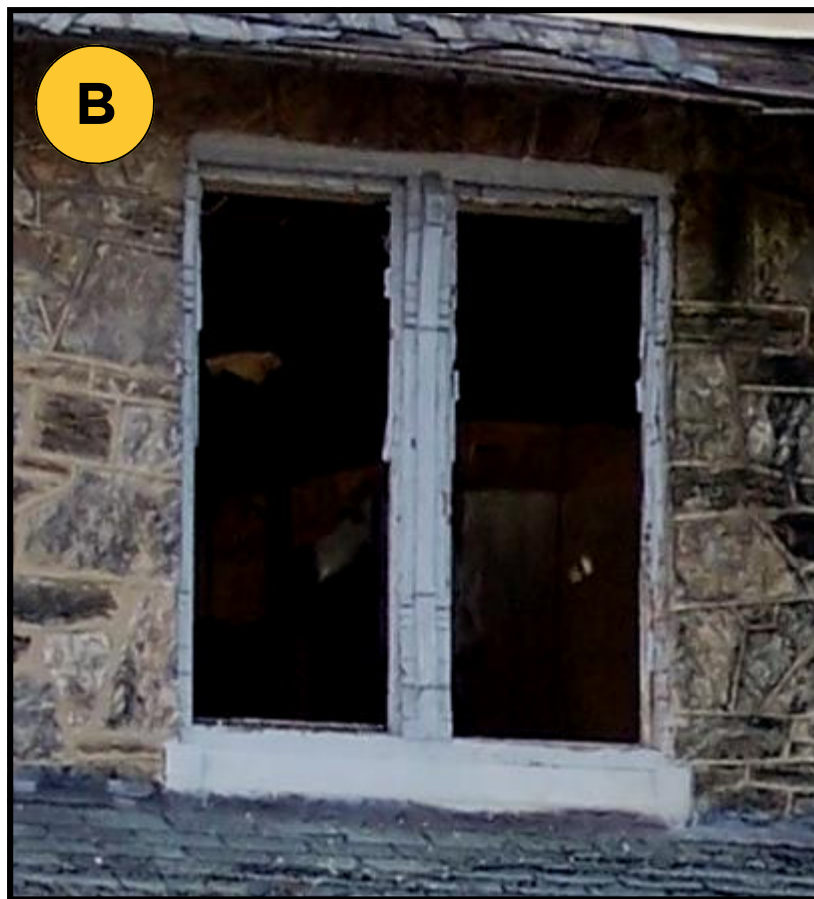
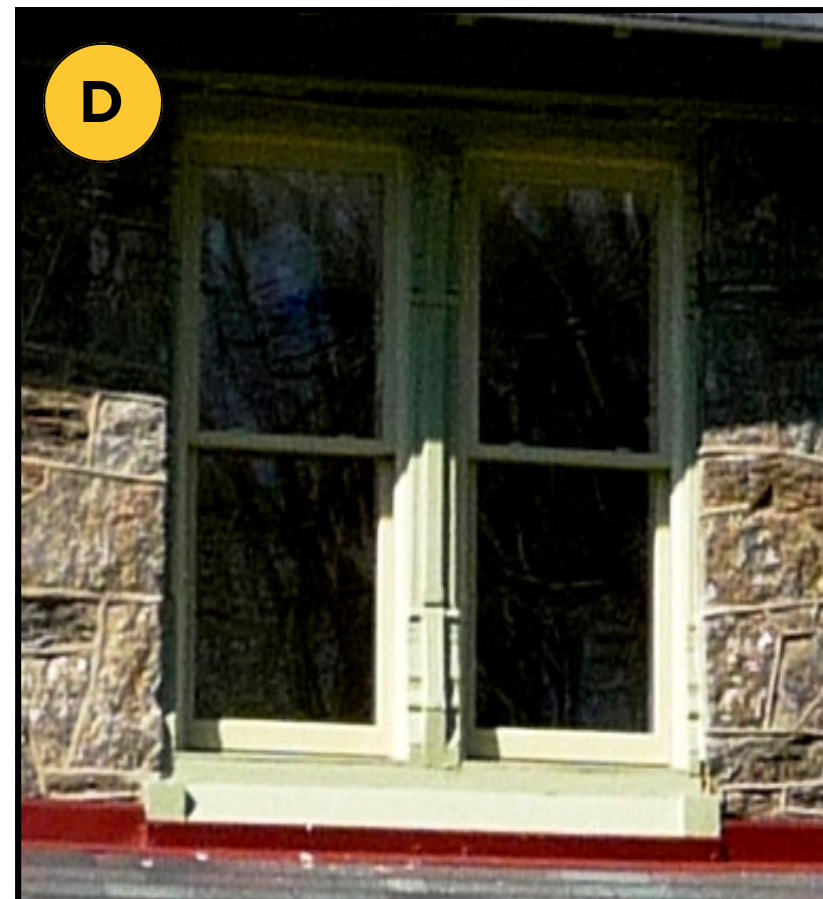
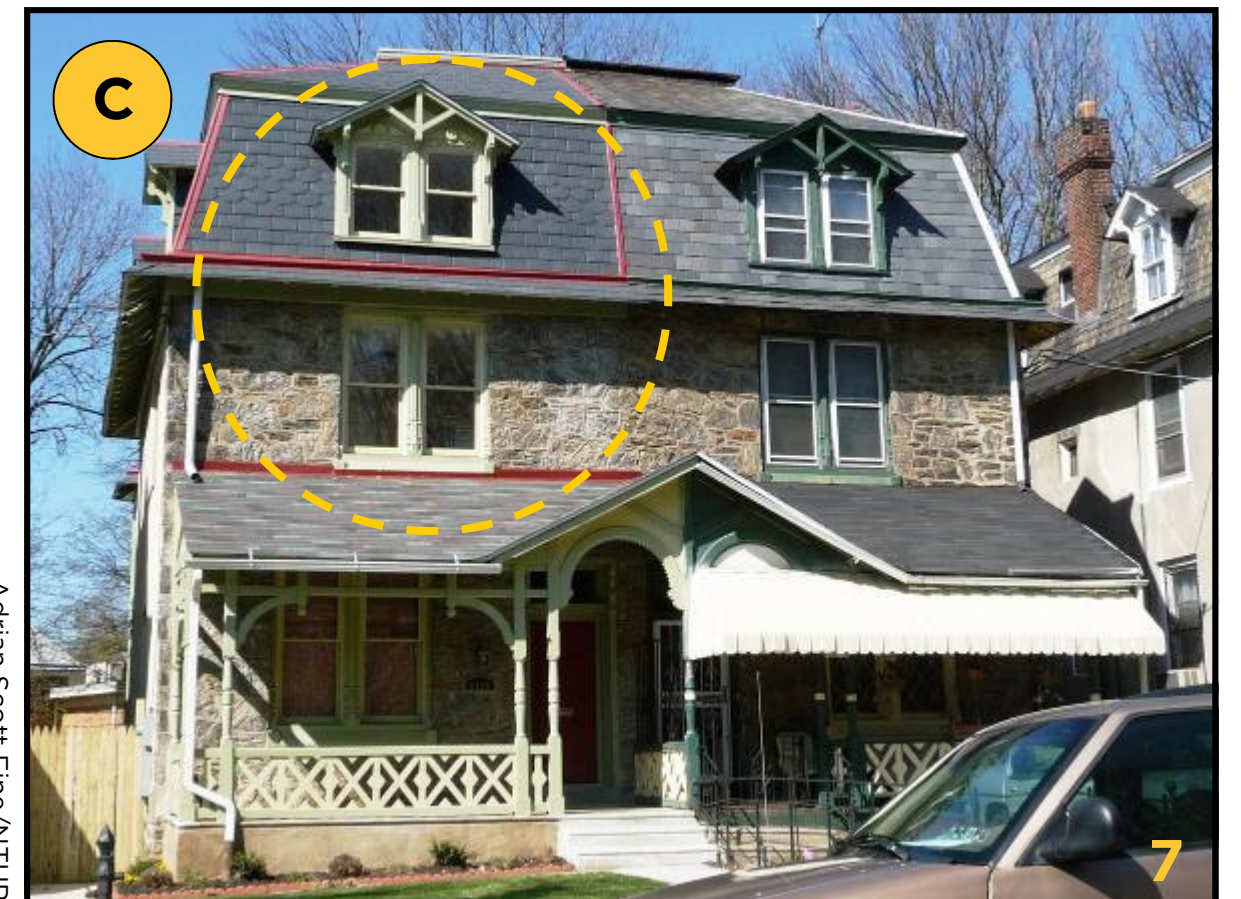
- A, B Original windows are missing but decorative casings and openings remain.
- C, D As part of the rehabilitation project, new wood double-hung sash windows were chosen to fit the original openings and the decorative casings were repaired and retained. New windows replicate the originals in terms of size, type, proportion and materials.
