NATIONAL
TRUST
FOR
HISTORIC
PRESERVATION®

Repair or Replace Old Windows

A Visual Look at the Impacts

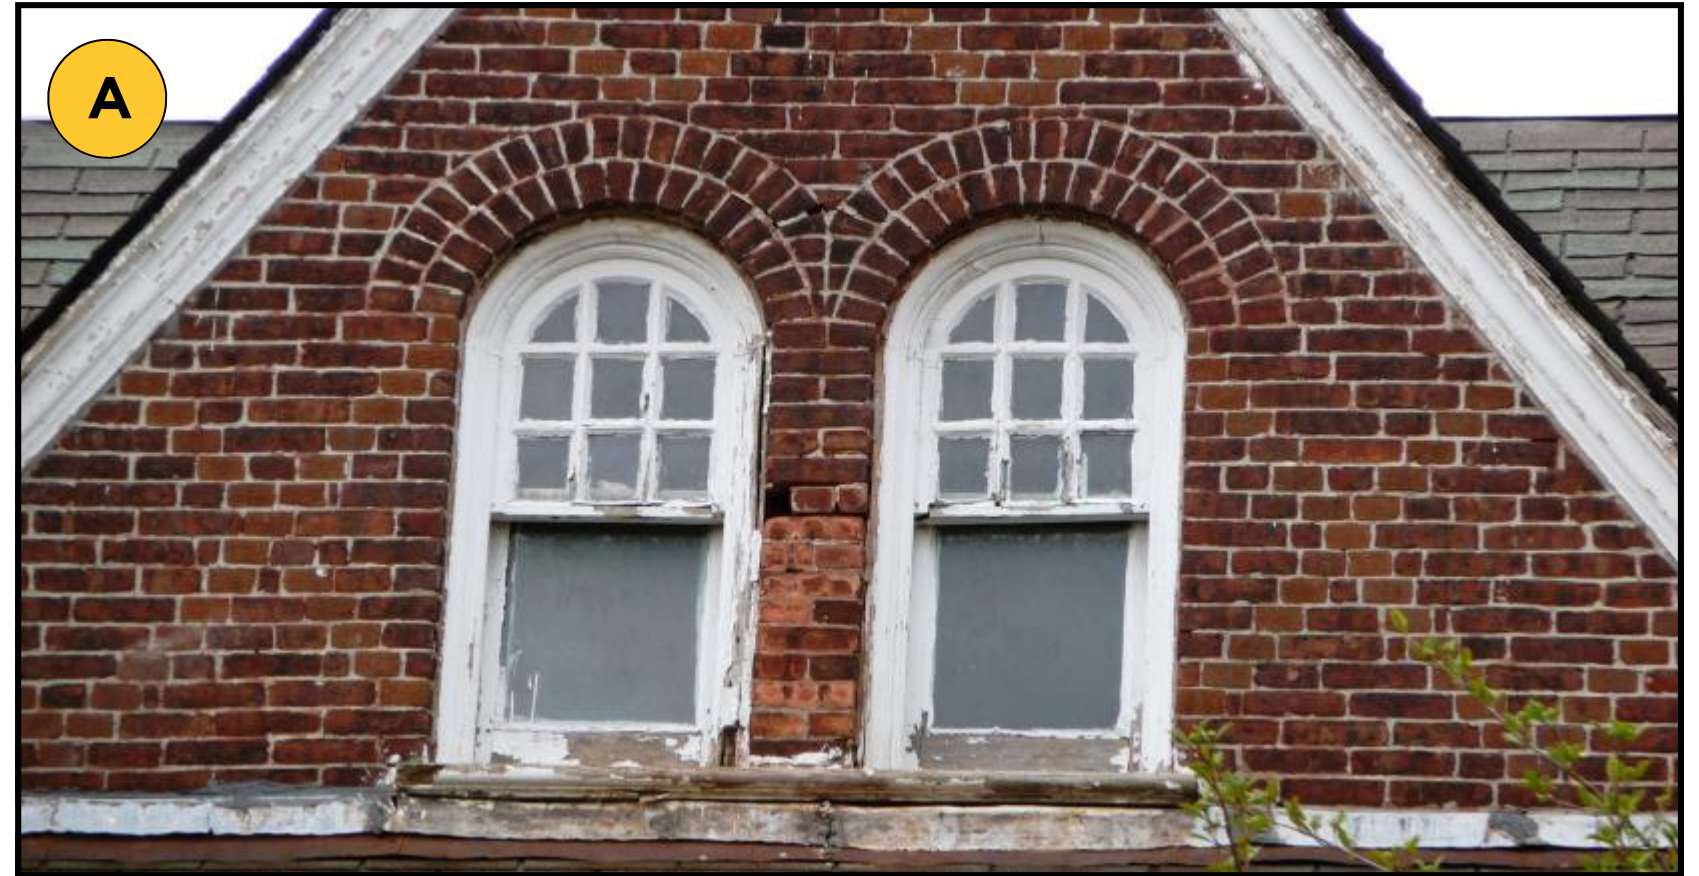
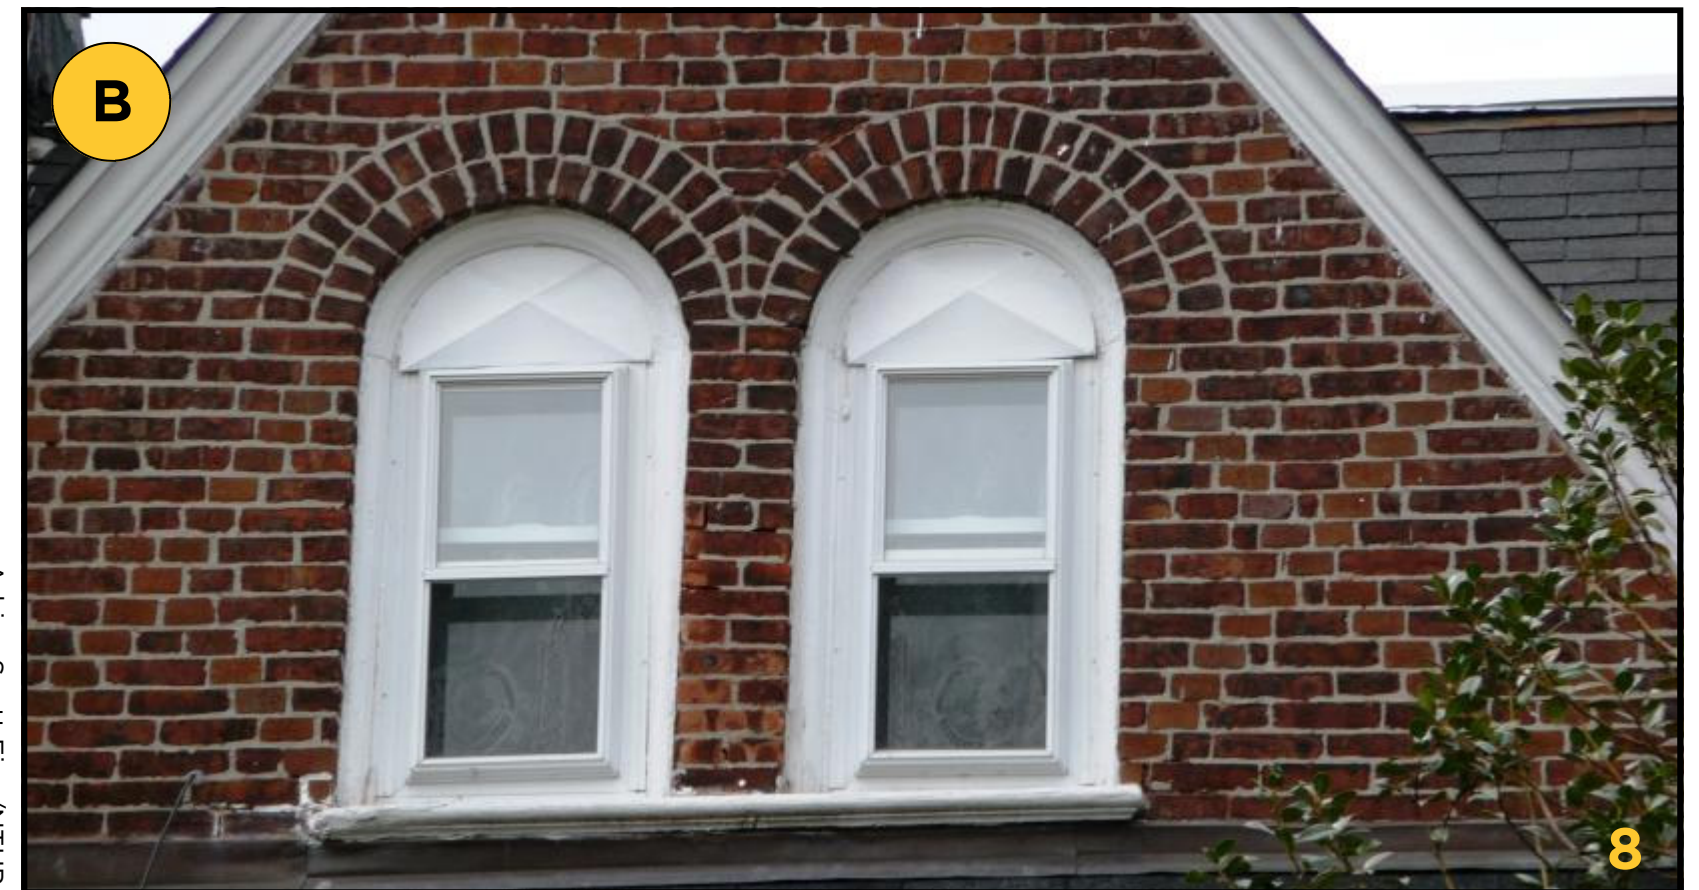
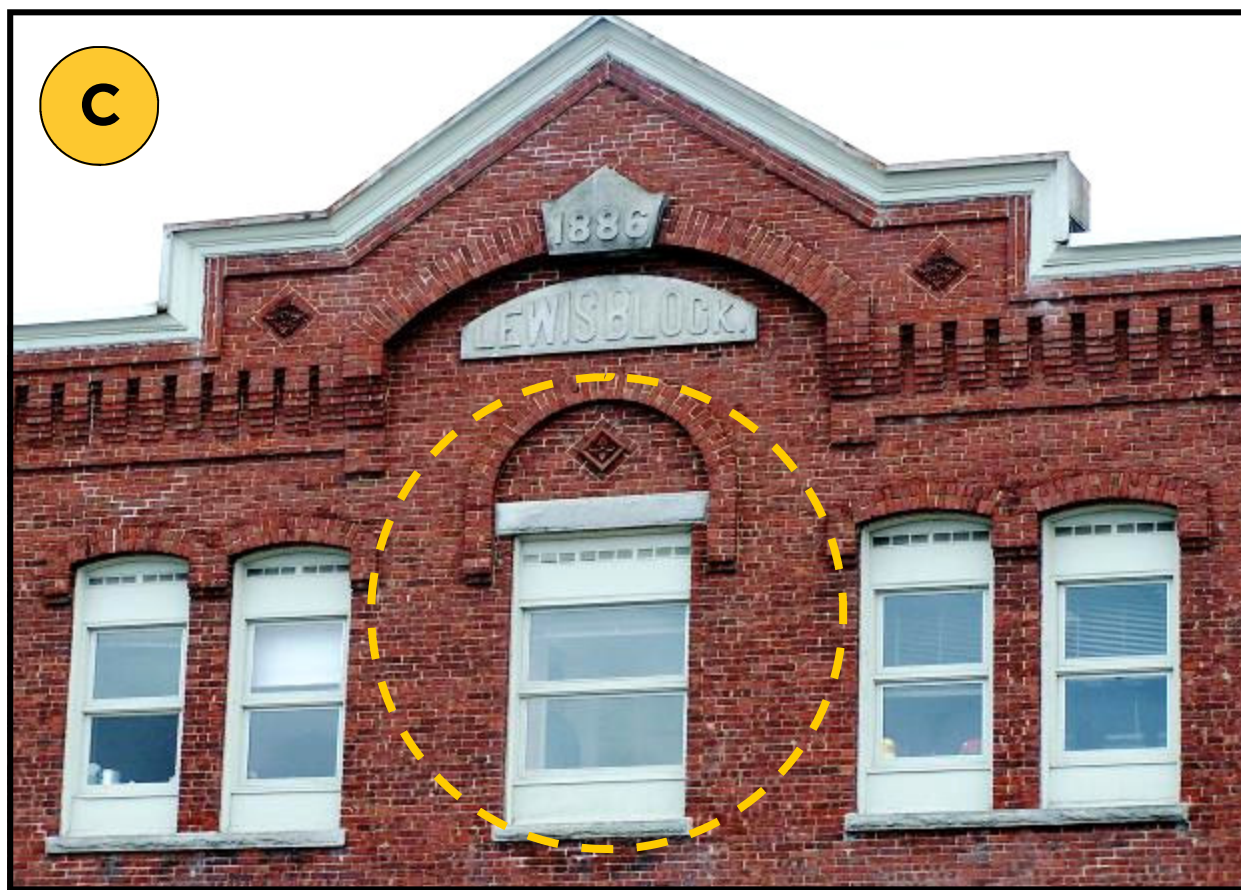
- A Two, arched nine-over-one double-hung sash windows are in disrepair with loose meeting rails and paint build up. They can be easily repaired and still maintain the character of the building.
- B An identical building with replacement windows. Stock units were used with aluminum in-fill around the opening. The difference in character between A and B is dramatic.
- C The upper story windows of this Main Street commercial structure were replaced with stock units with in-fill at the top and bottom.

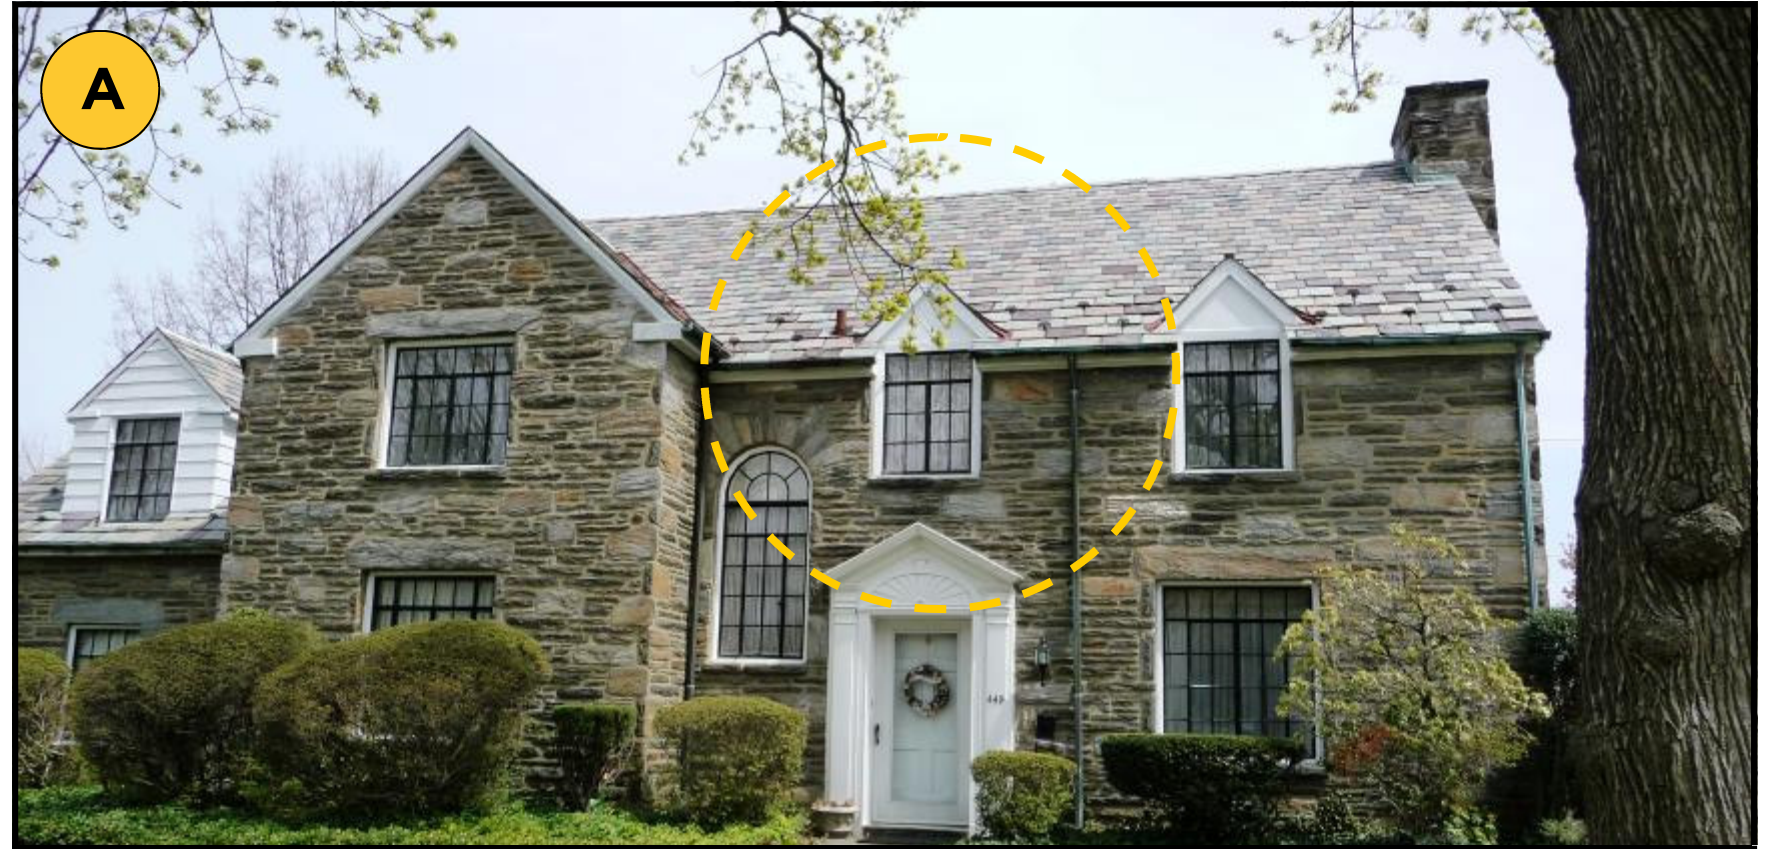
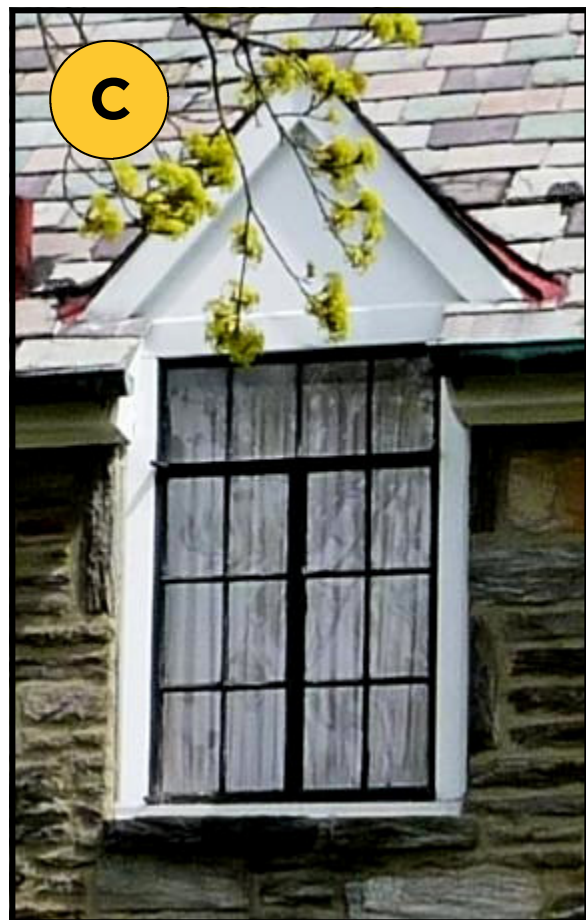
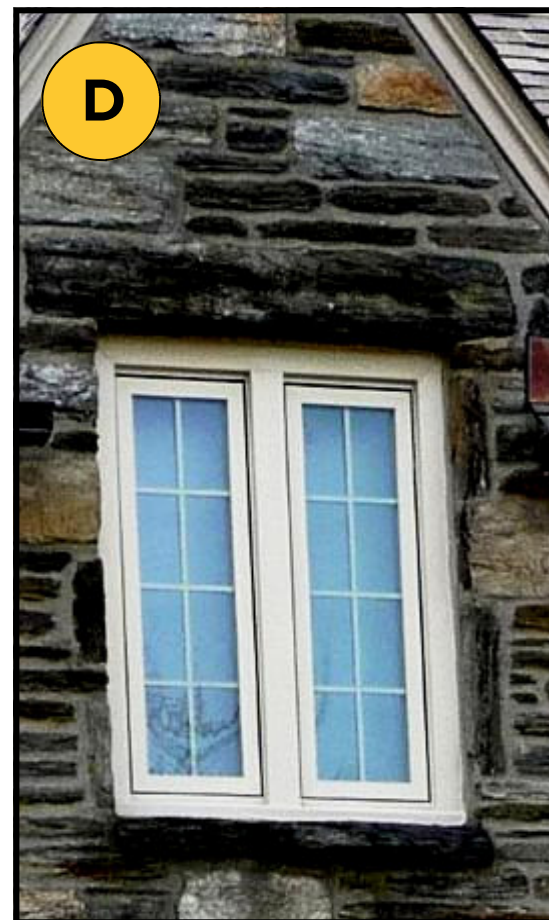
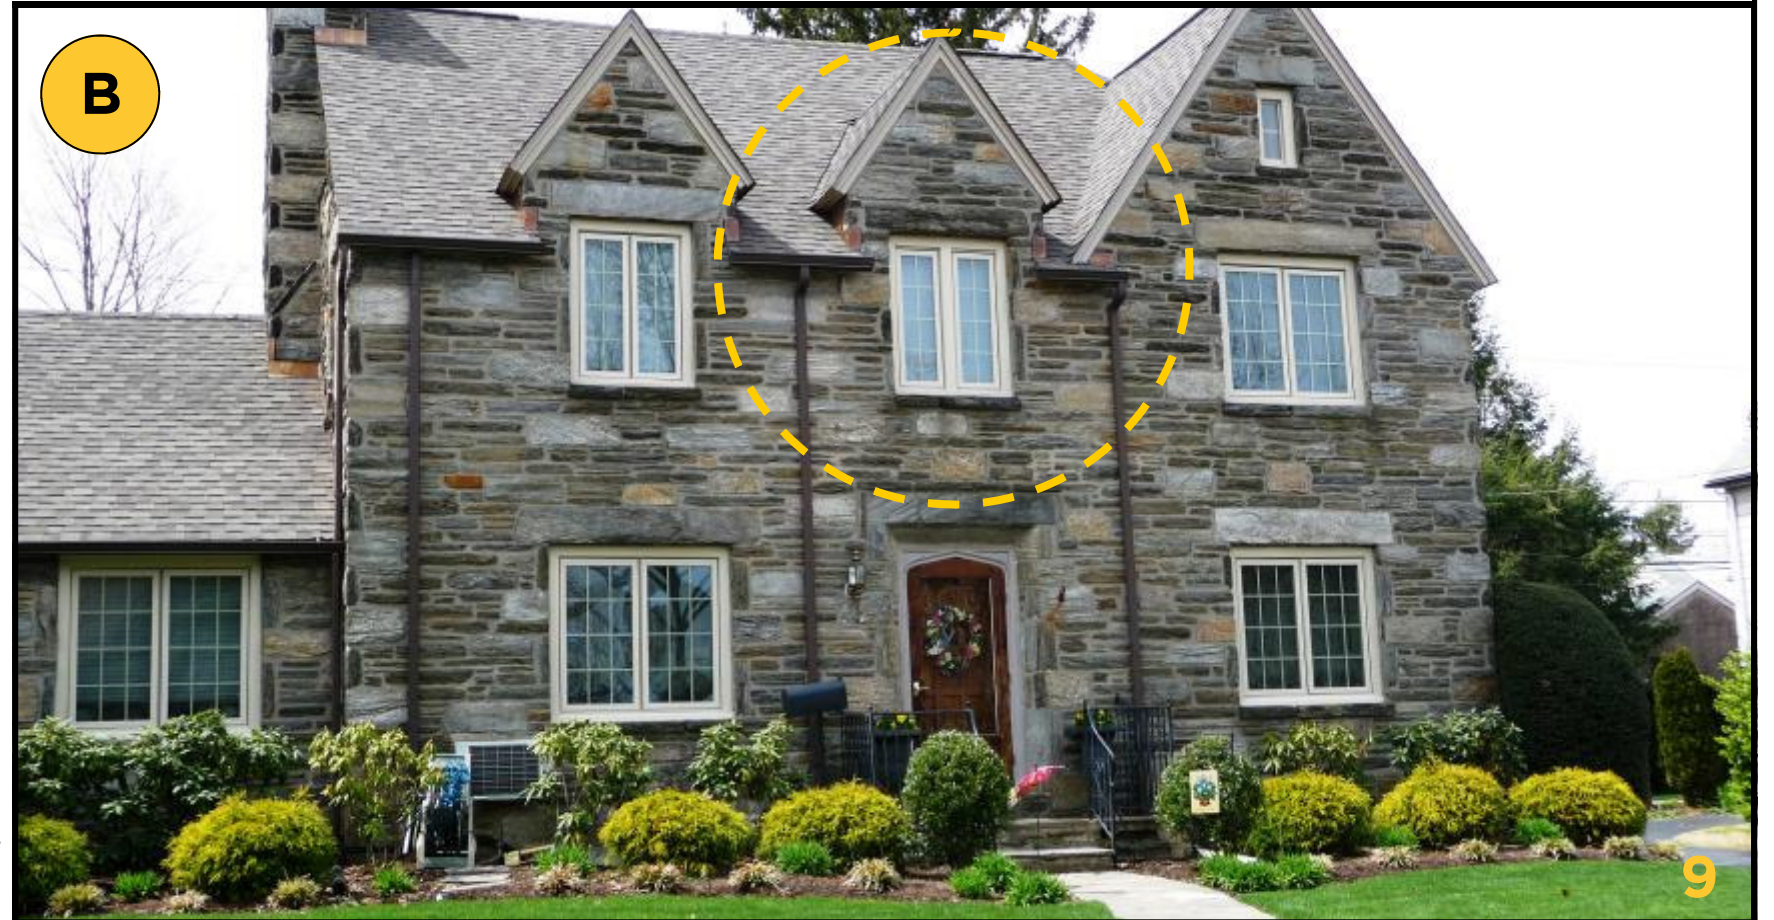
- A Steel casement windows with fixed transoms and side-lights, featuring interior storm windows. These windows are a character defining feature of the house.
- B Replacement windows attempt to match with casement style units yet the proportion, pattern, width and lack of a true divided-light miss the mark.
- C, D The differences between the original and replacement are readily seen, where the wider casing and surround are much prominent on the replacement windows.

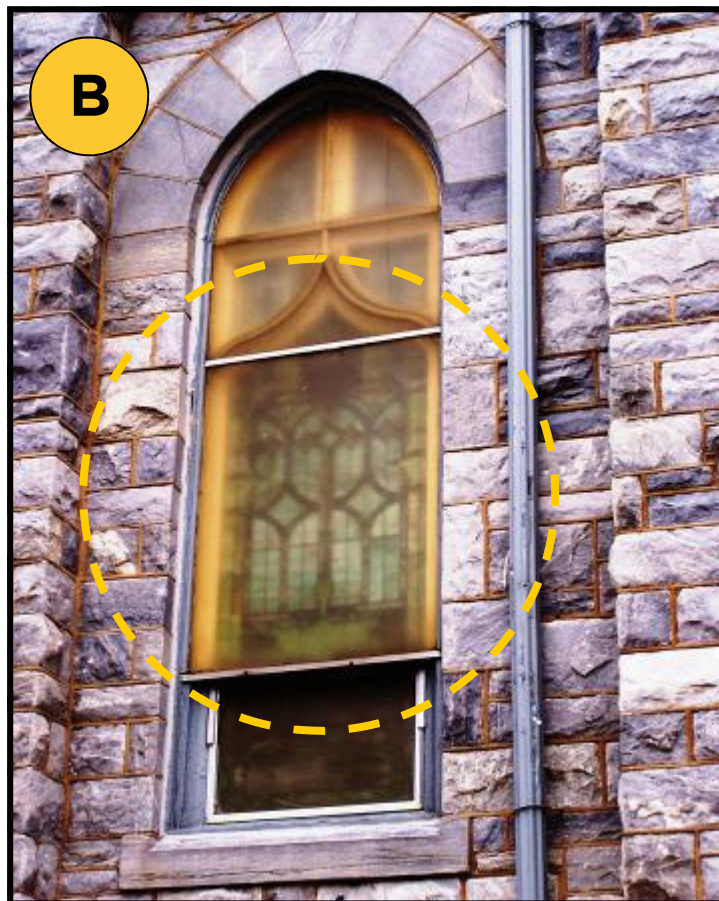
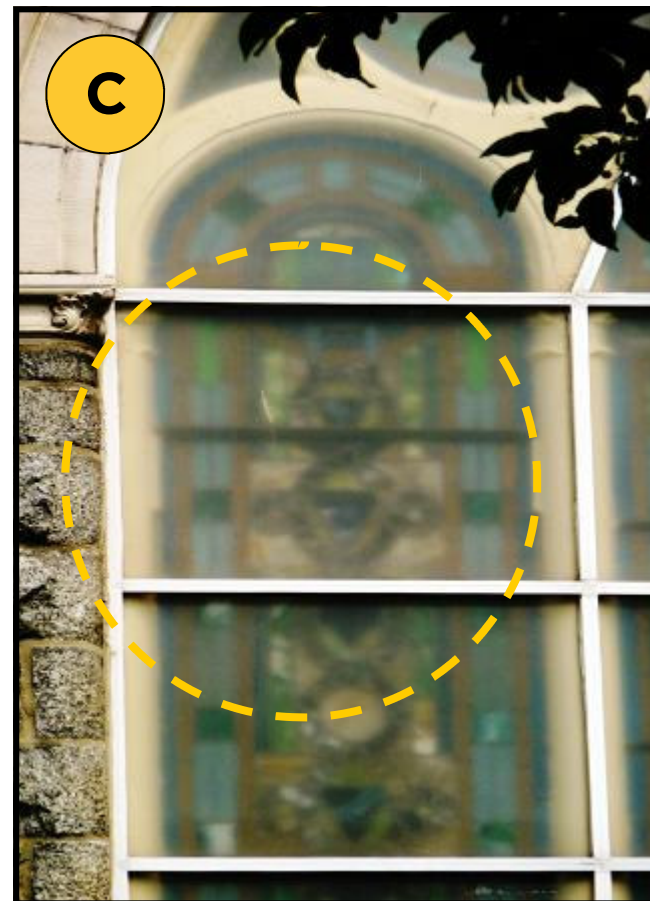
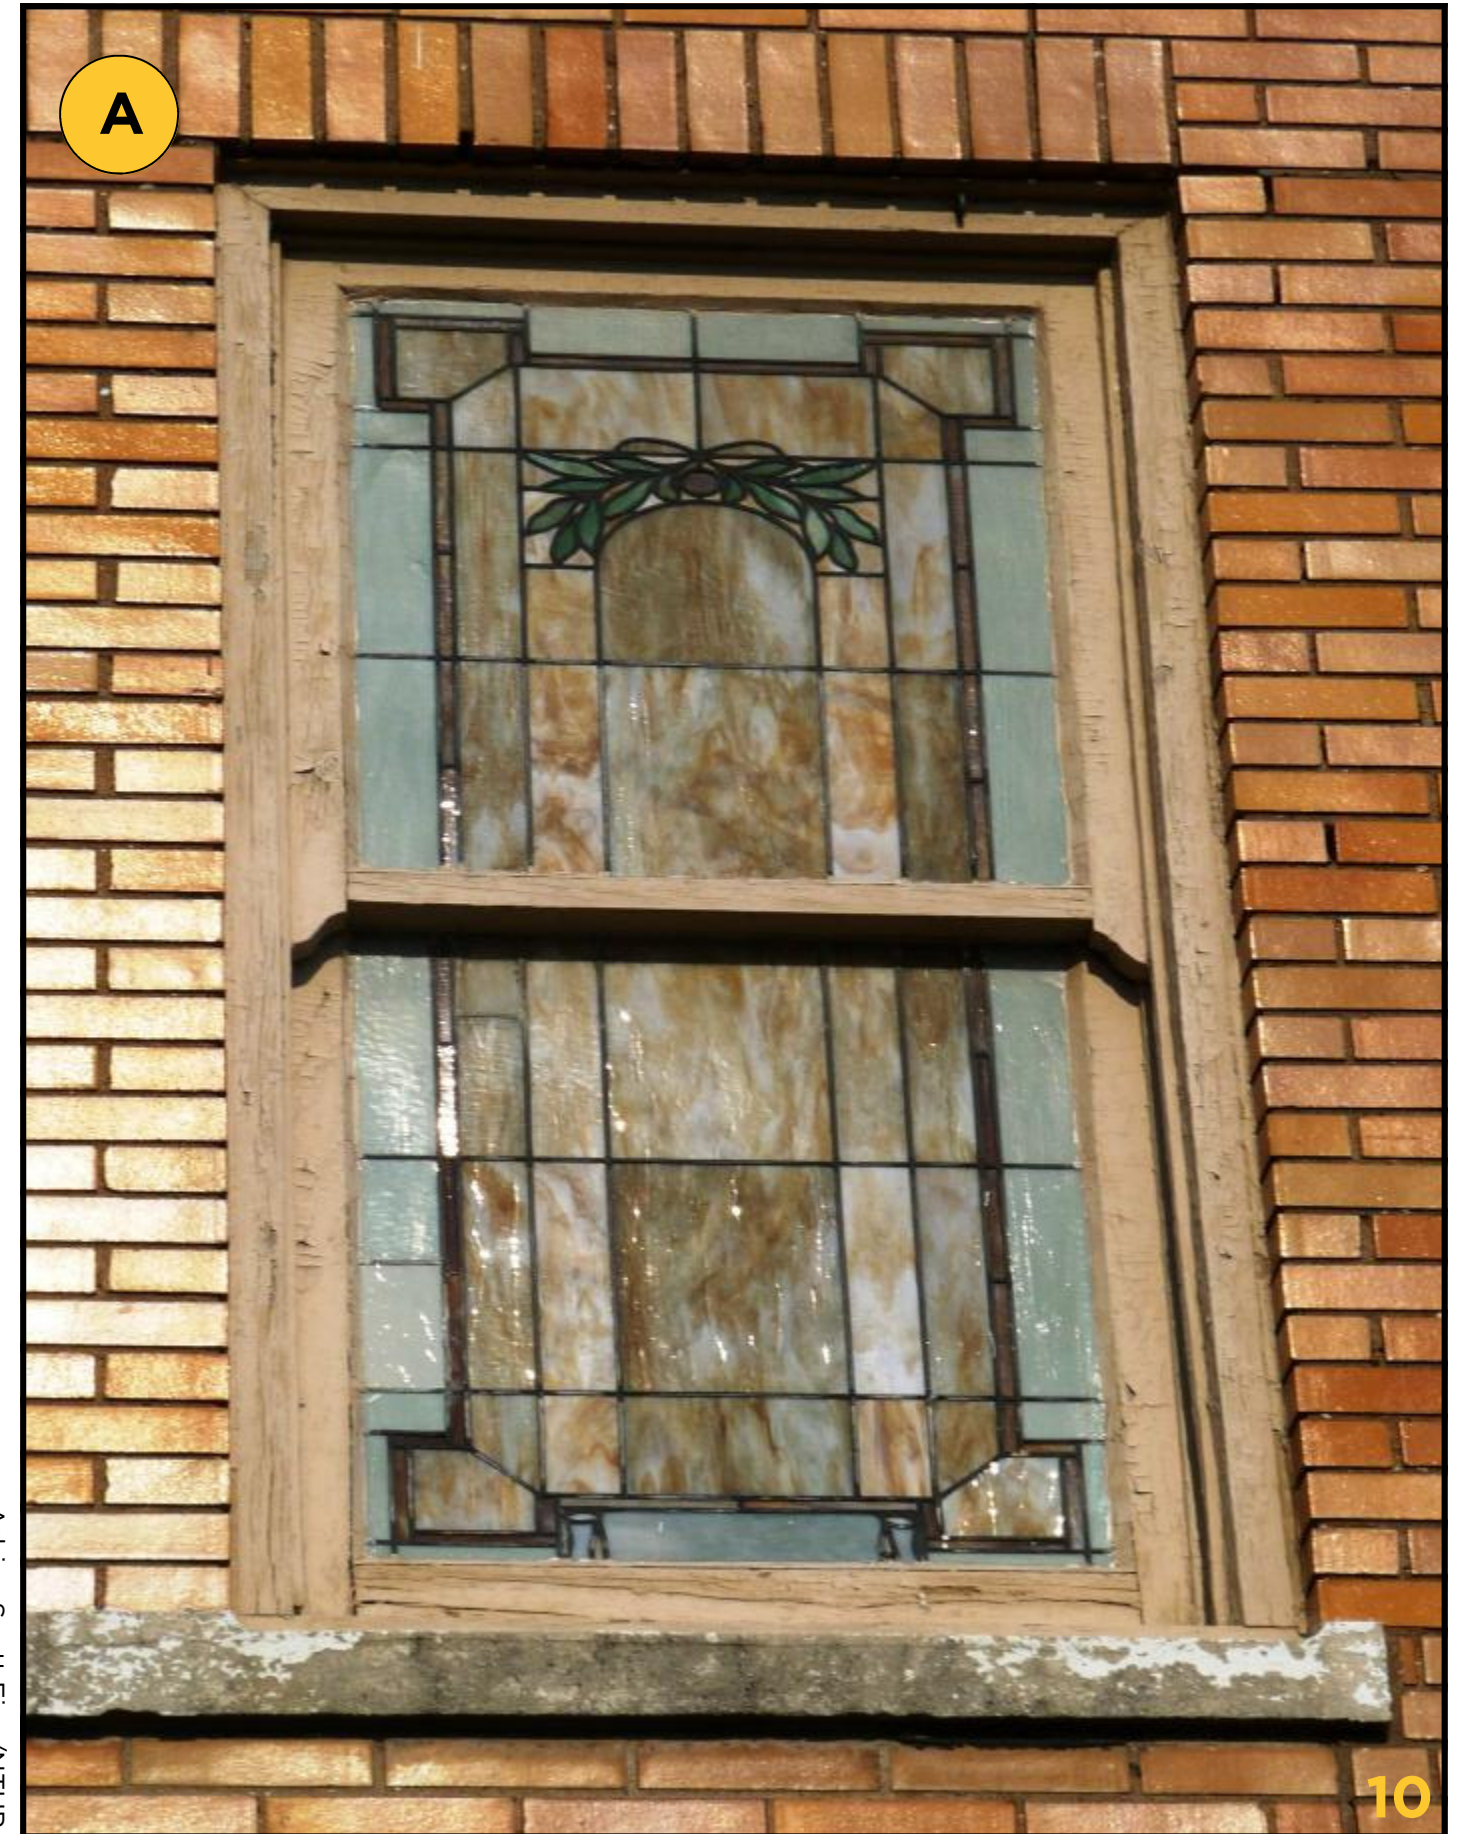
- A Exposed original one-over-one double-hung slag glass window .
- B Plastics (Lexan or Plexiglass) are impact-resistant and nearly shatter-proof but tend to yellow and get hazy over time.
- C Windows are obscured and the pattern is dramatically altered with new aluminum rails as part of this protective glazing system.

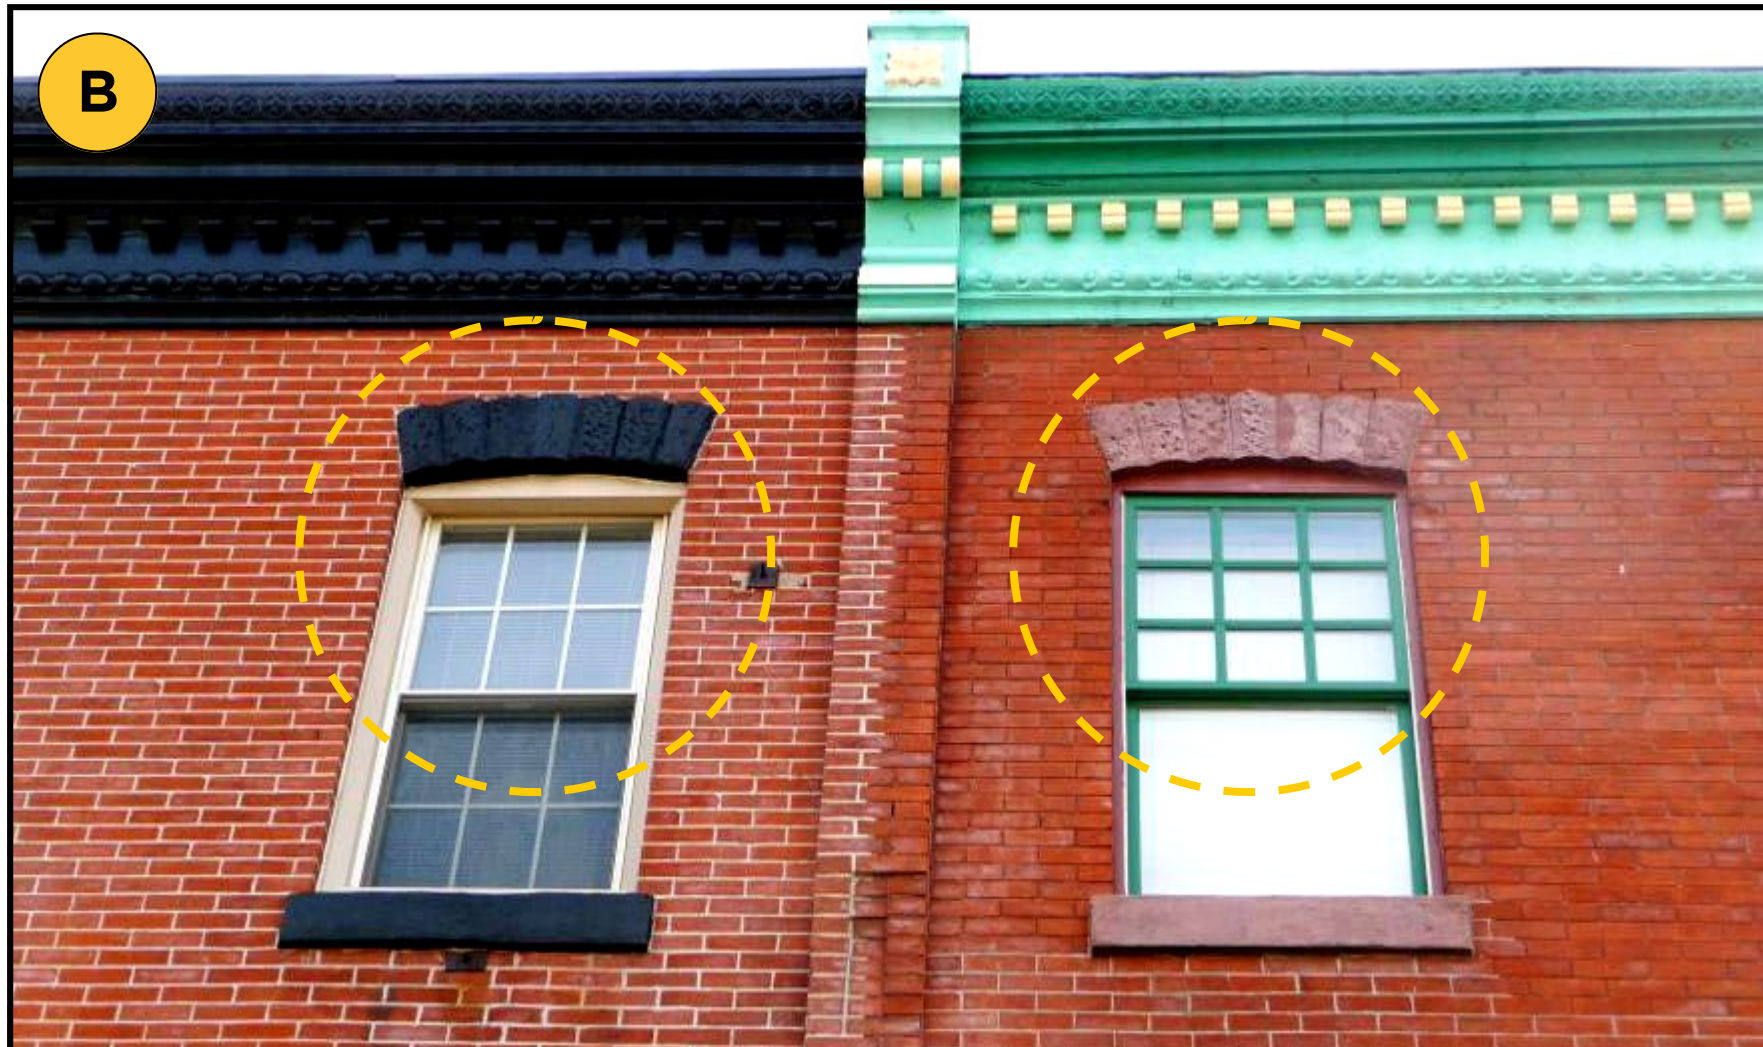
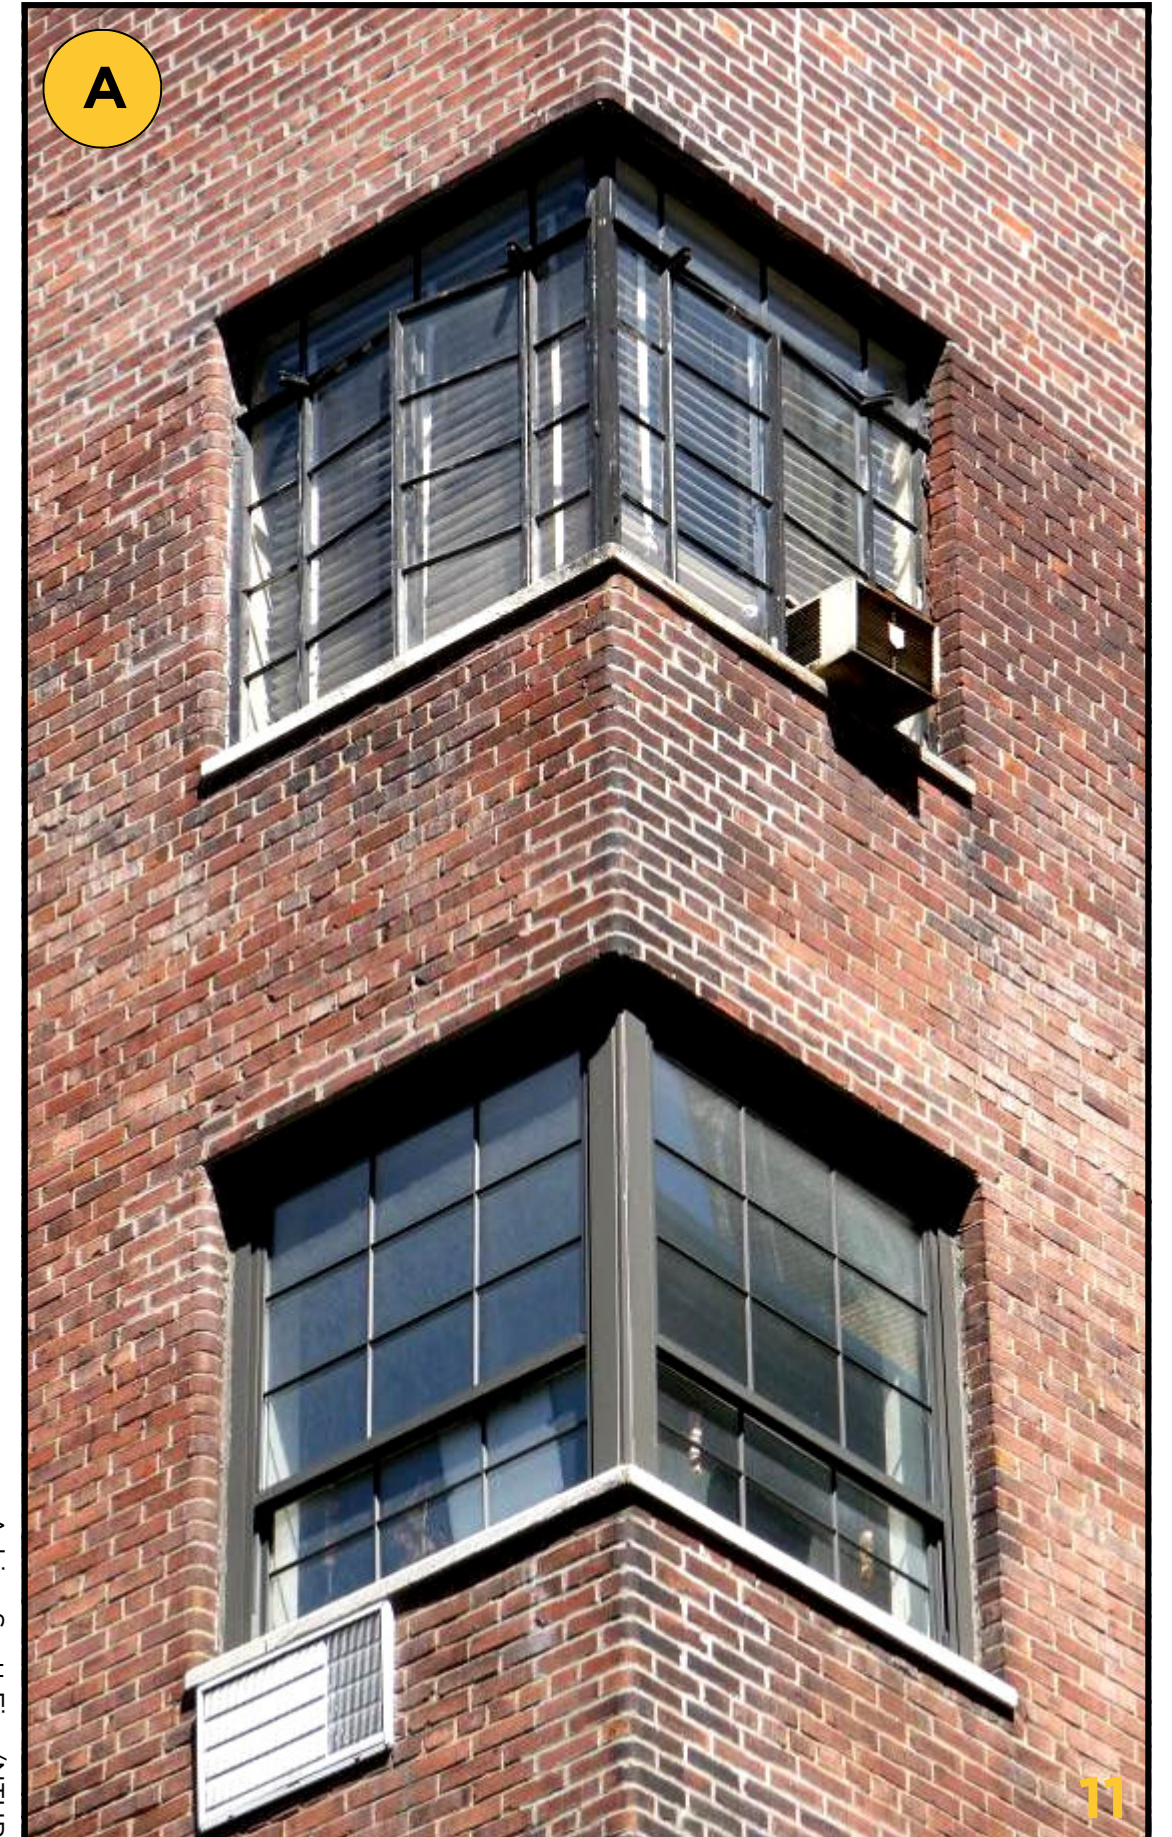
- A An early 1940s apartment building designed in the Art Deco style features corner, steel casement windows. The slender profile of the muntins and casing is a character defining feature. The replacement double-hung sash window, at the bottom, attempts to match the lines of the original, yet the muntin pattern and width of casing are much different.
- B Two double-hung sash replacement windows on side-by-side row houses demonstrate the subtle, but noticeable differences in design. While original windows were identical, these are different in terms of depth, muntin size and pattern and width of casing.

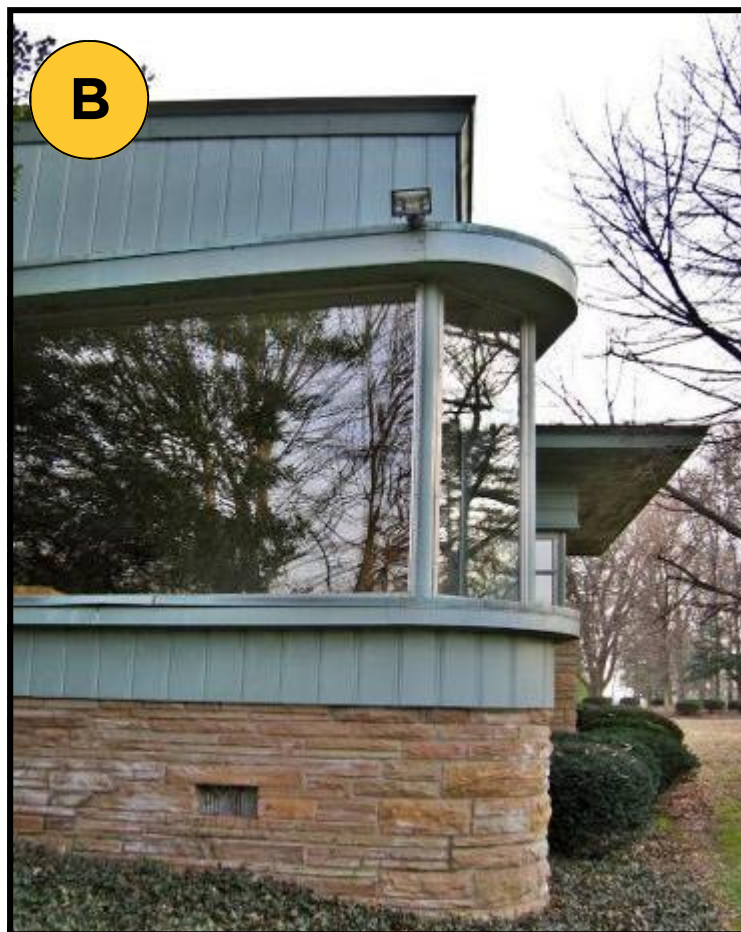
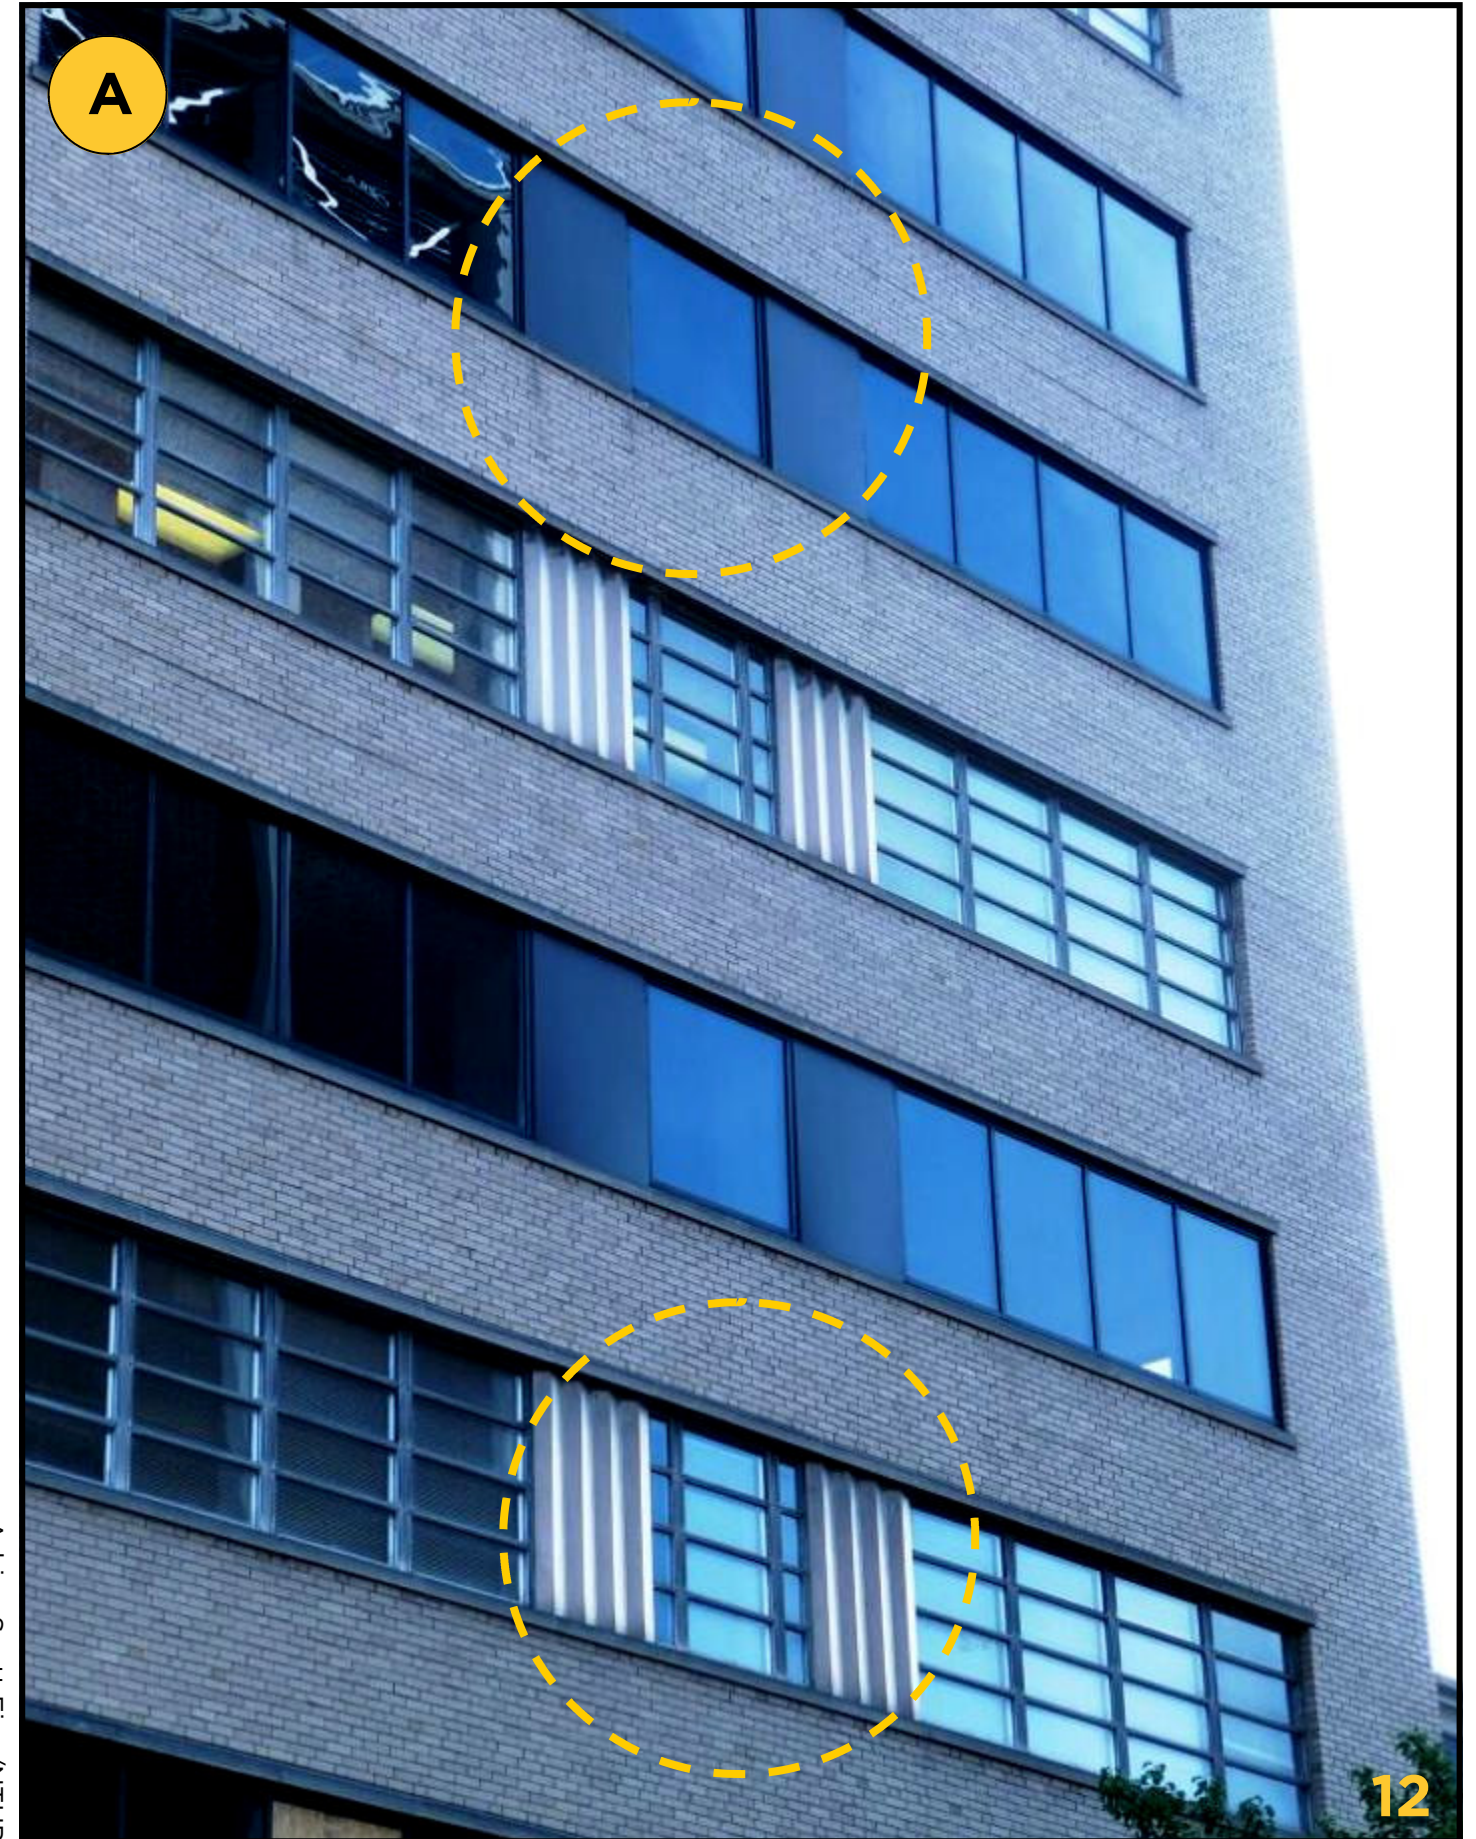
- A Original, character defining windows and corrugated stainless steel detail are being removed on this 1950s office building, replaced by dark tinted fixed windows that do not match.
- B, C Large spans of single pane and plate glass require innovative solutions, such as custom designed storm windows.
