NATIONAL
TRUST
FOR
HISTORIC
PRESERVATION®

Repair or Replace Old Windows

A Visual Look at the Impacts

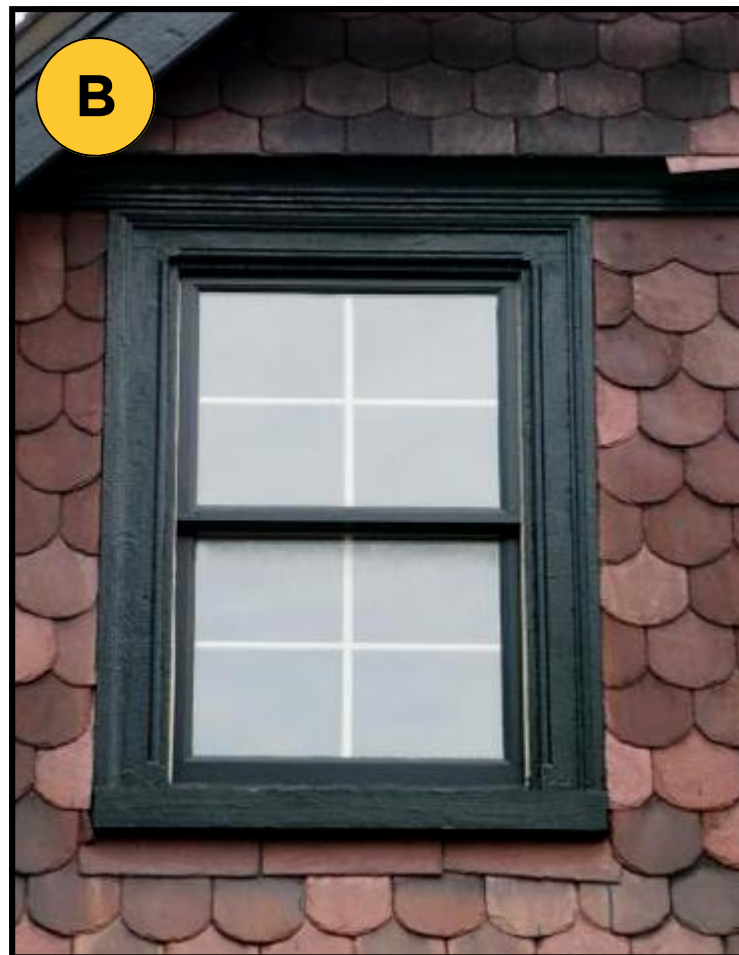
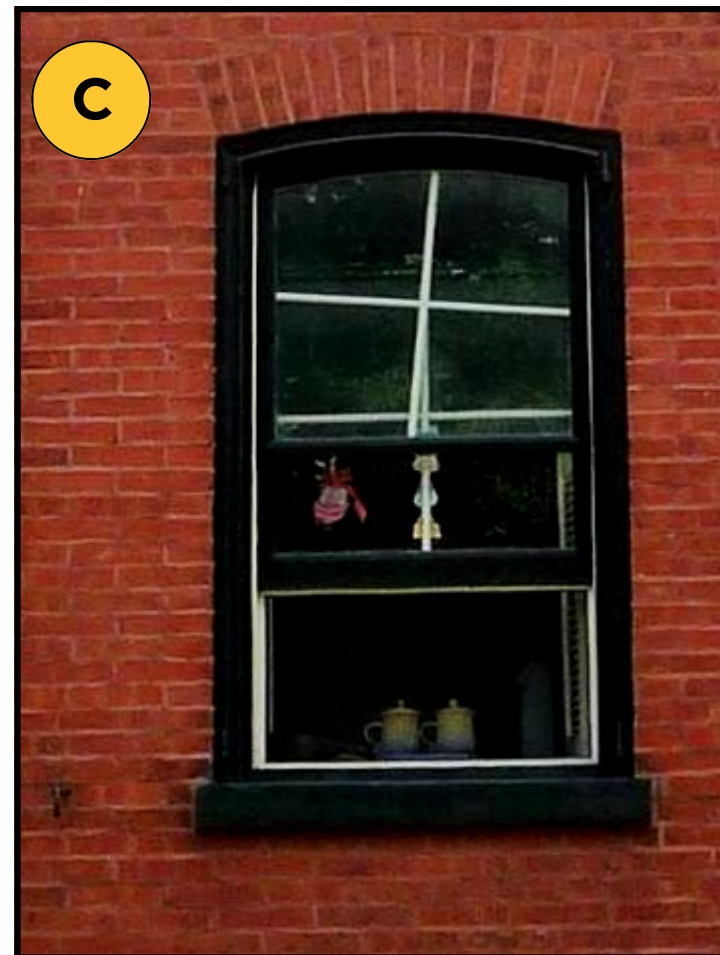
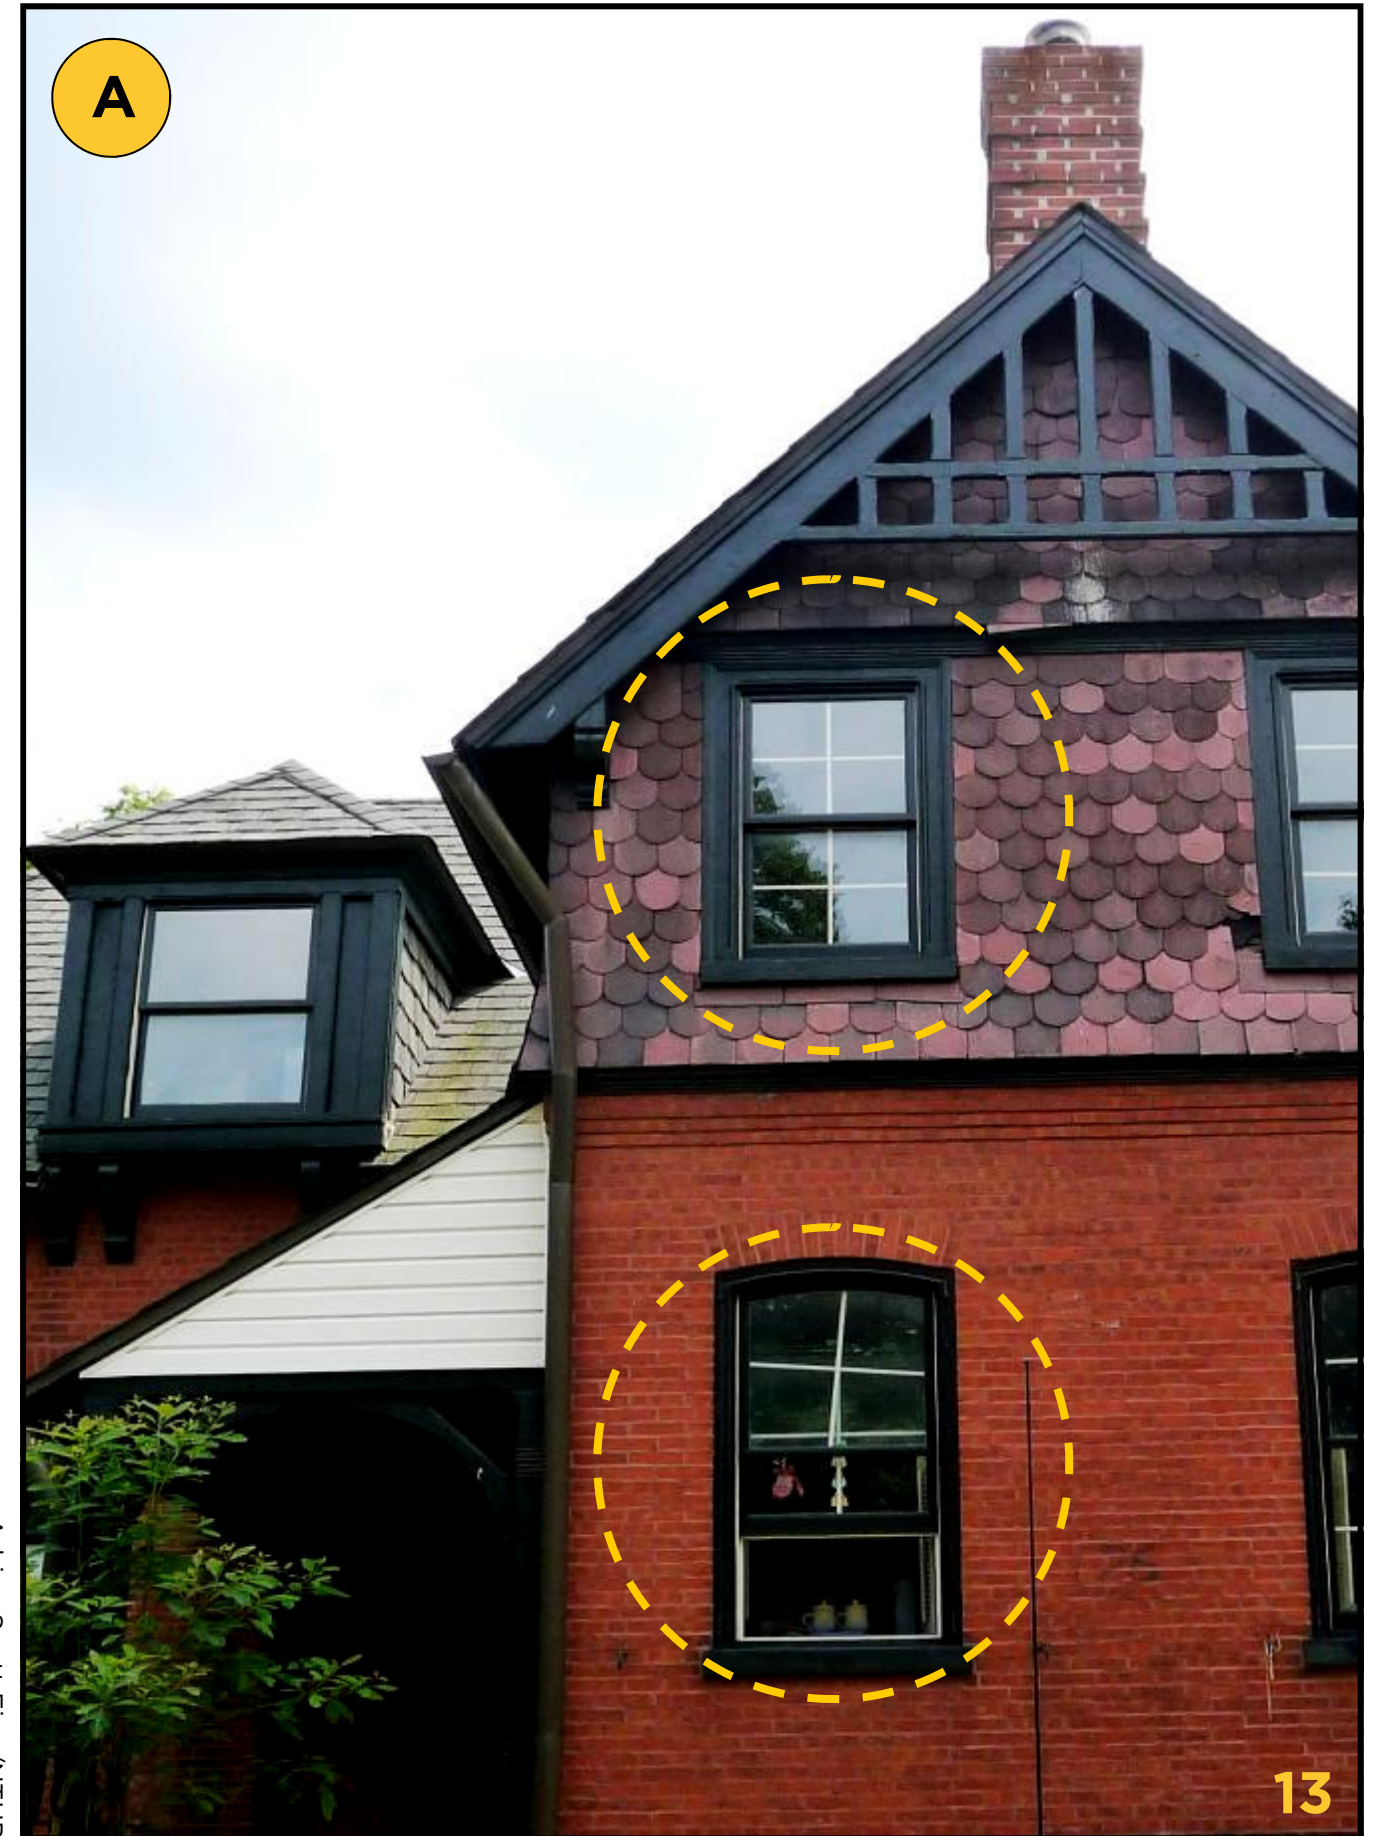
- A A former carriage house, rehabilitated and preserved for a new use, features replacement windows that attempt to look like true divided-light windows.
- B This four-over-four double-hung sash still has its original wood casing with a replacement window with clipped on interior muntins. There is little dimension or depth with this design and instead looks like a one-over-one sash.
- C This shows how clipped on interior muntins can loosen or fall off.

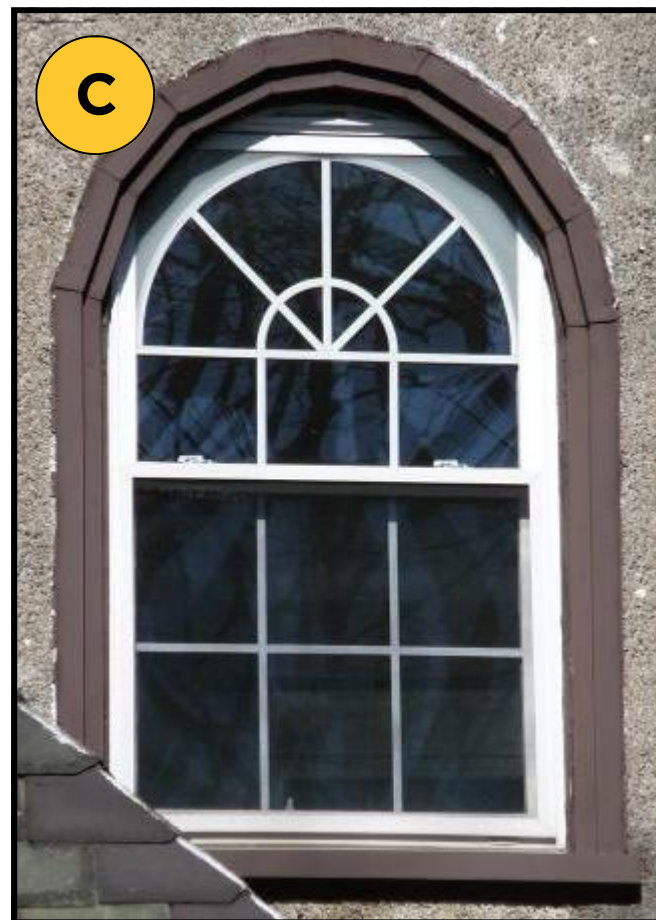
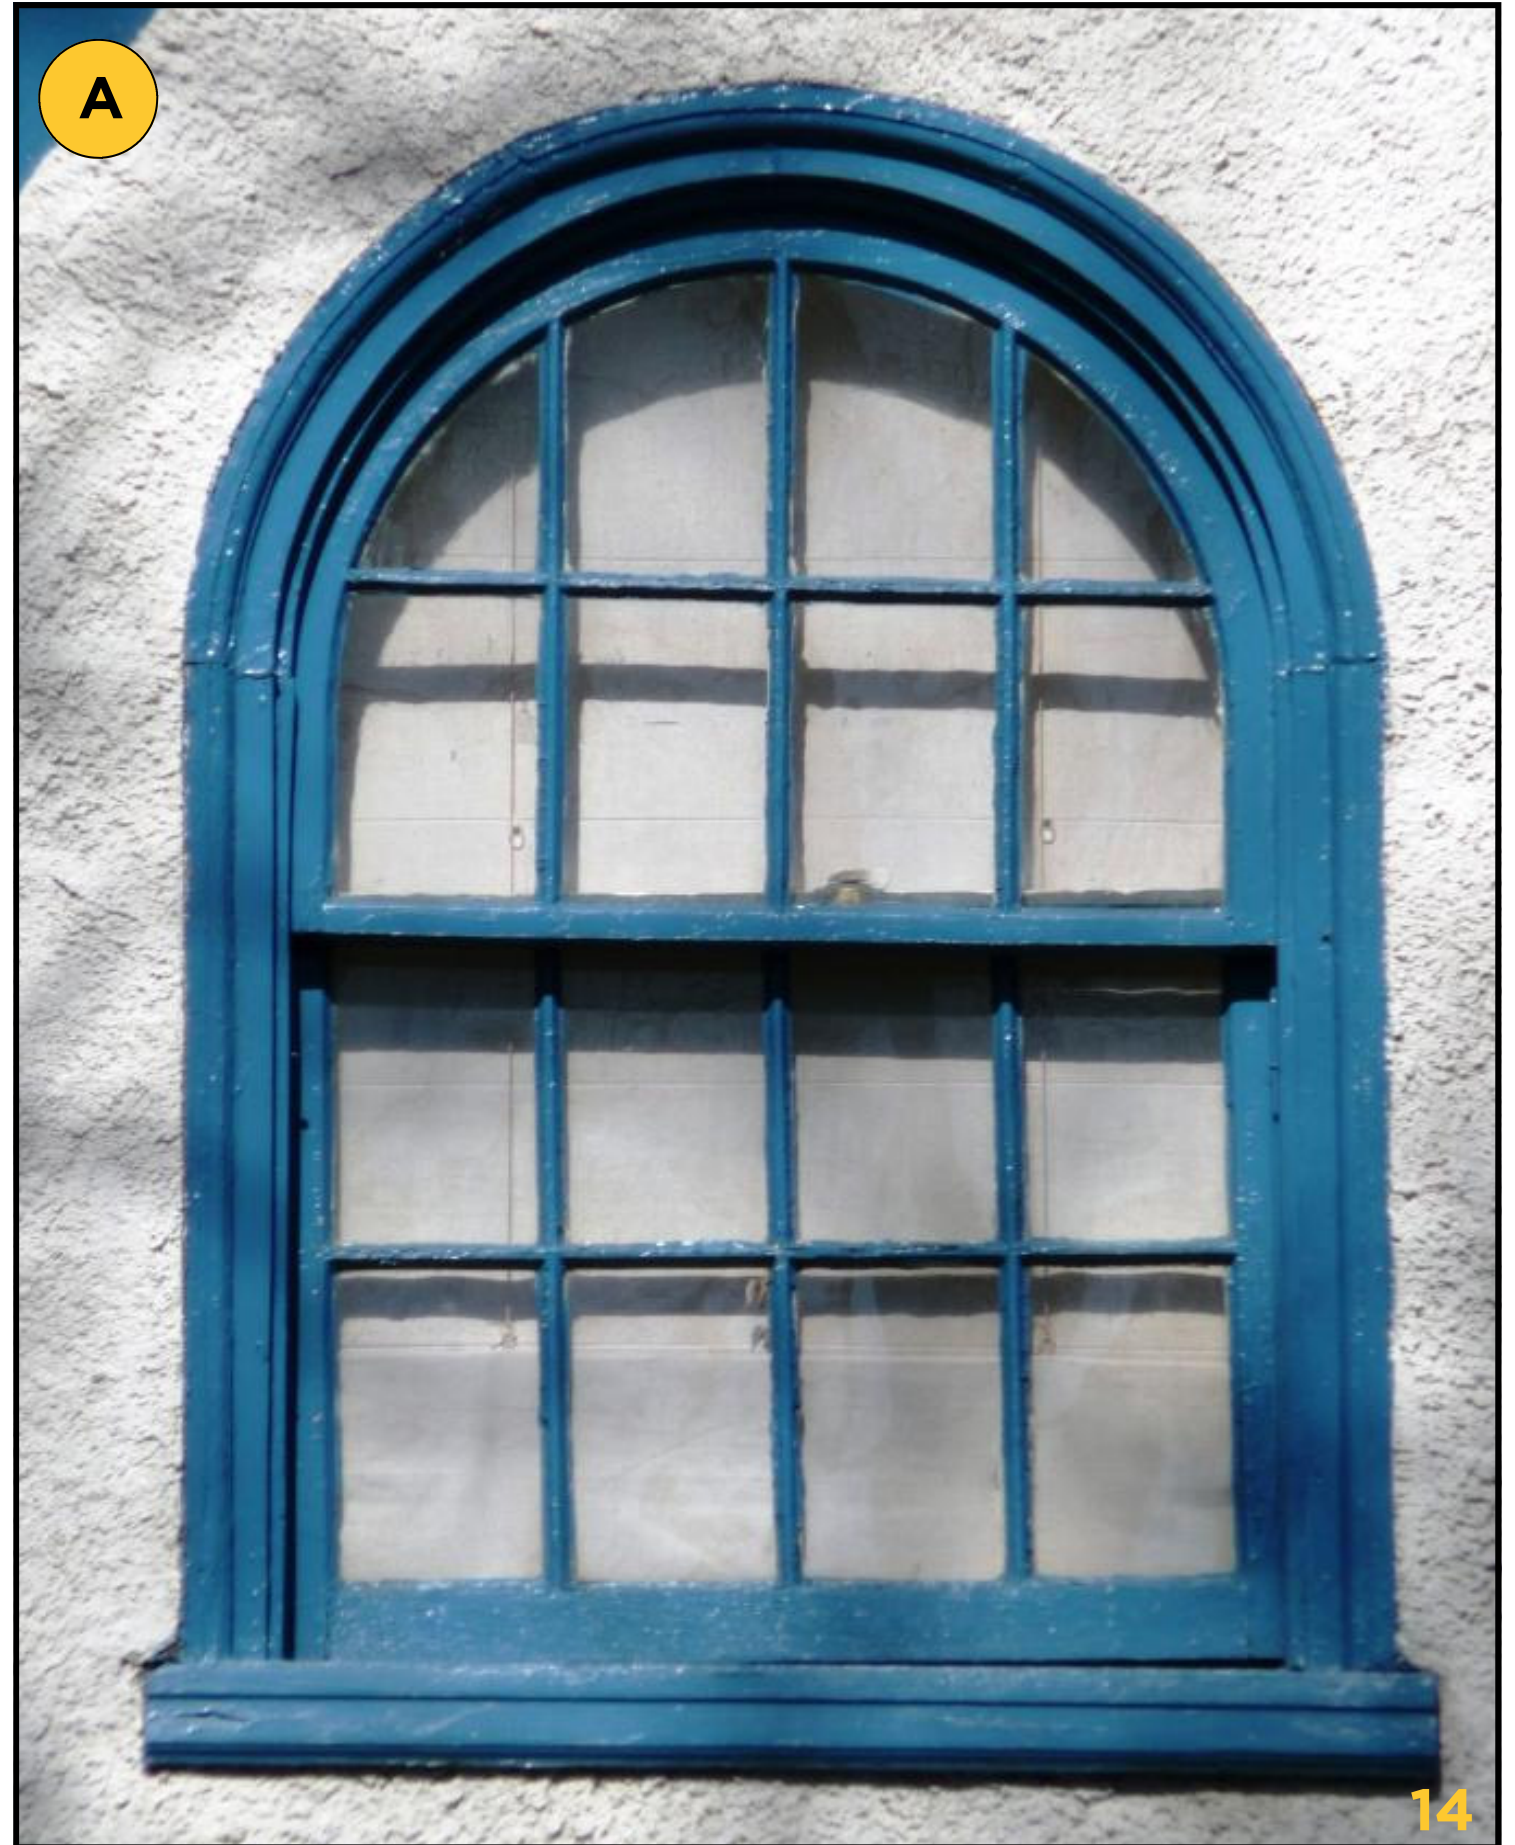
- A This eight-over-eight double-hung sash window with wood casing and sill is a common feature on houses in this neighborhood.
- B This replacement window attempts to replicate details of the original. However, it is not a true divided-light, the casing is wrapped in aluminum and the upper sash is flat and not round arched.
- C This replacement tries to look like a round arched window but is instead flat, features a completely different muntin pattern, has casing wrapped in aluminum and is not a true divided-light.

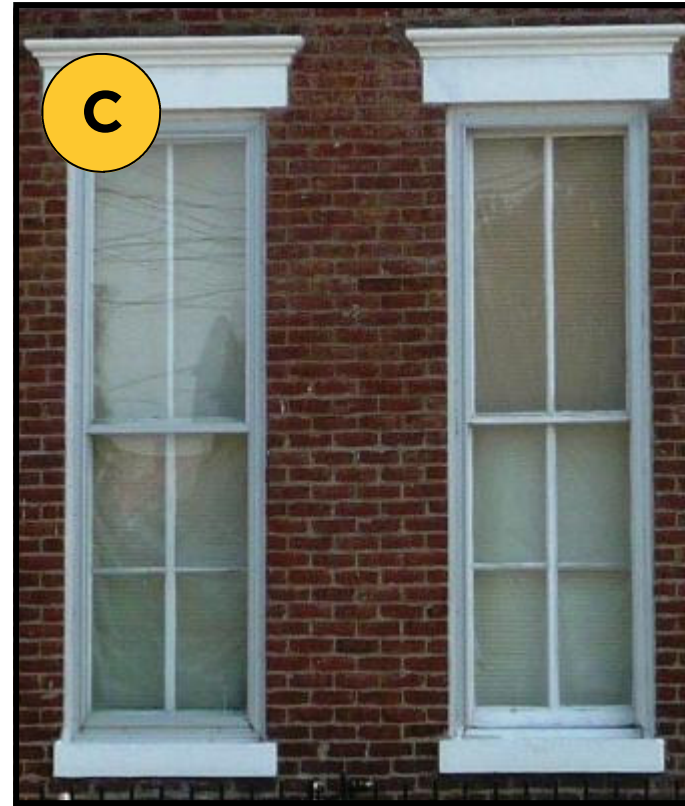
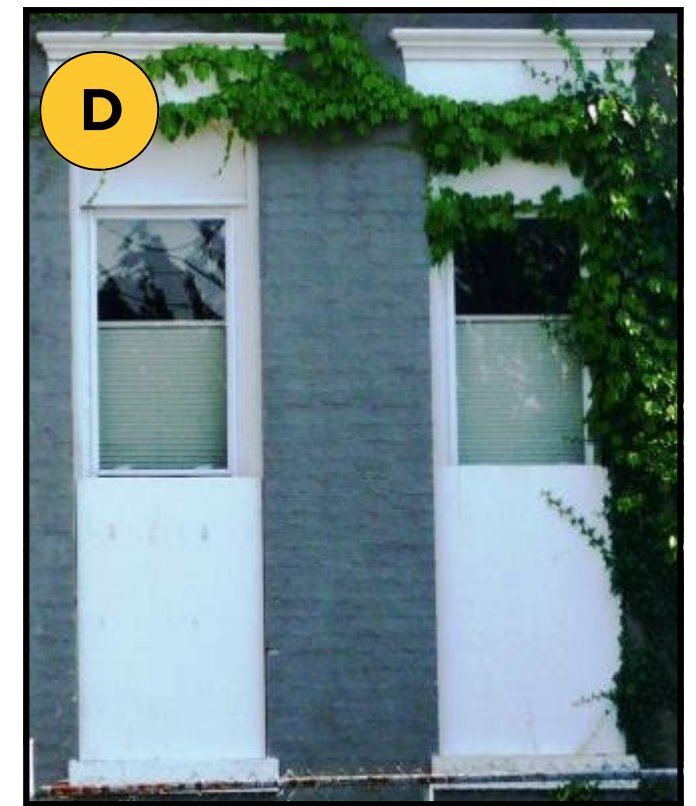
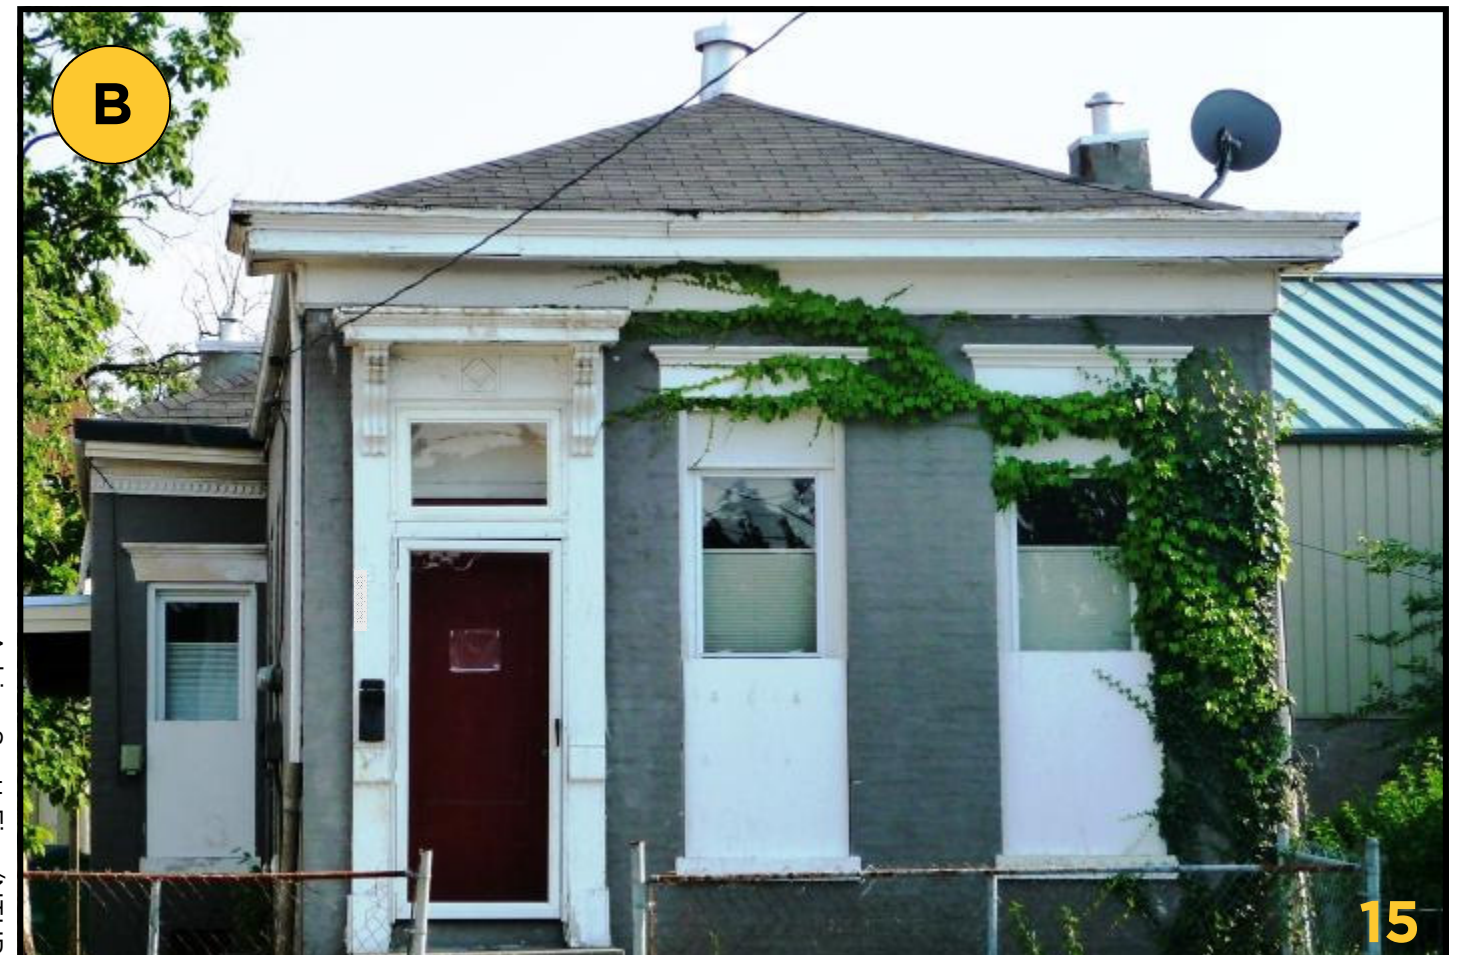
- A, B Two simple Shotgun style homes that were once nearly identical, to each other, and throughout the neighborhood.
- C Original two-over-two double-hung windows are a very prominent feature of these homes, directly relating to the size of the main entrance.
- D. The original windows were replaced, the openings reduced, and stock windows installed that are no longer in scale to the proportions of the house.

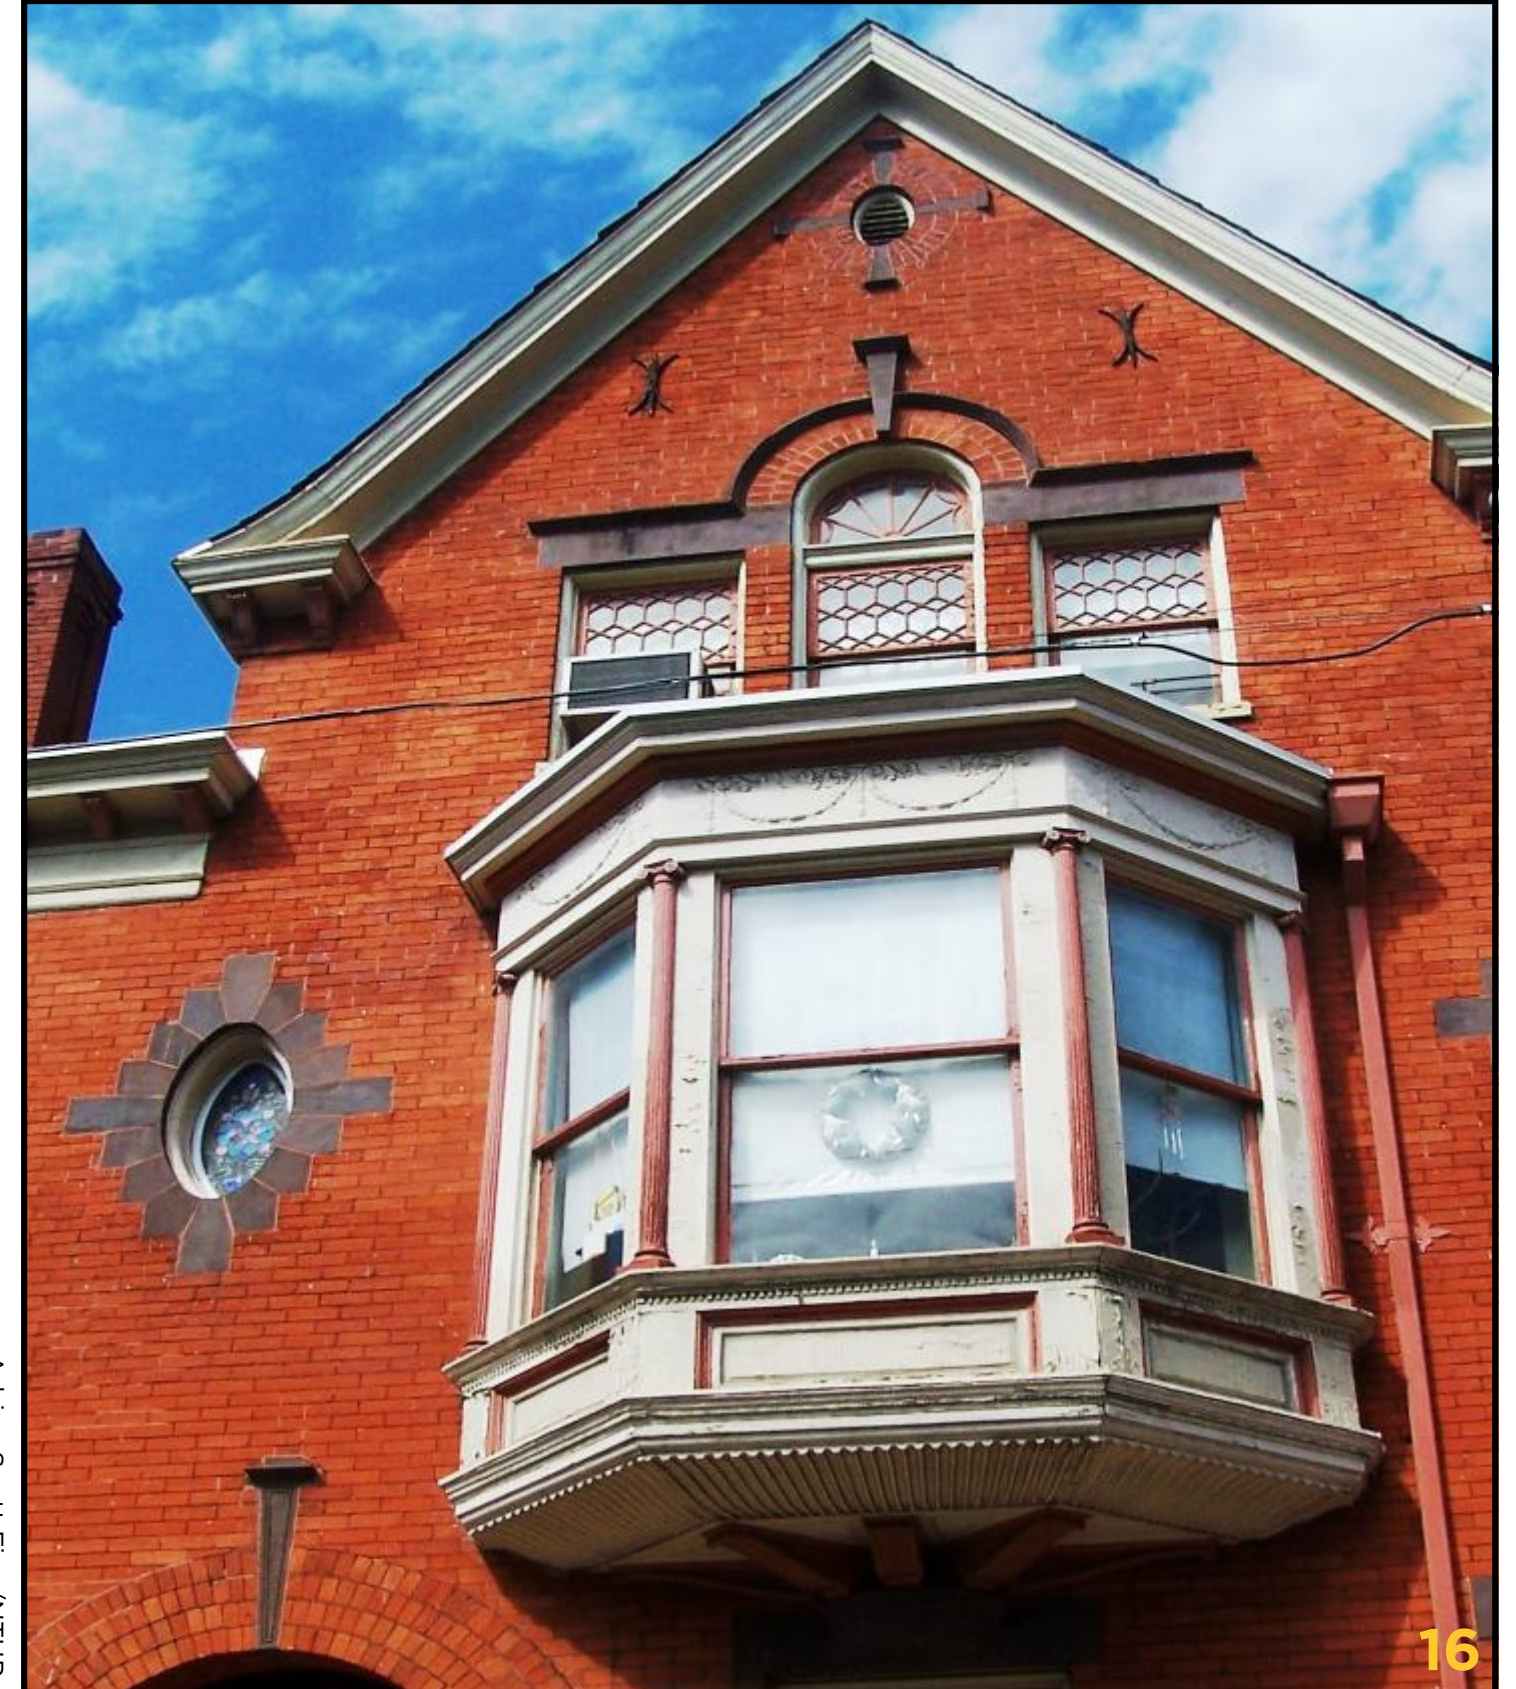
Early 20th century Queen Anne style house
Original windows help define the character of older buildings
